## INFORMATION SHEET

# Ammonium nitrate emulsion tanker trailer explosion – a brief summary for the transport industry

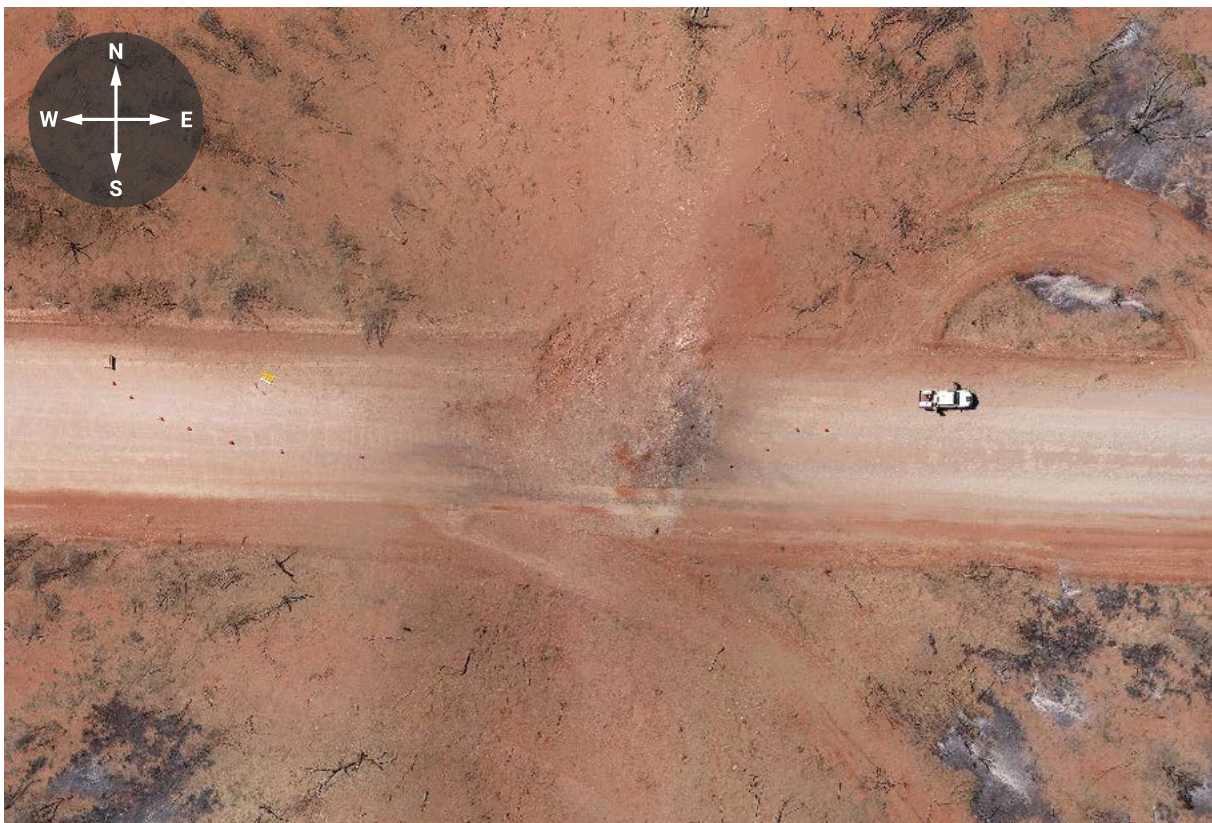
The explosion completely destroyed the dolly and tanker trailer and formed a large, shallow crater in the road, with the deepest point being approximately 1.1 m deep. The crater was irregular in shape, roughly elliptical, 17 m long by 9 m wide, with a total area of approximately 120 m<sup>2</sup>.

The likely cause of the tyre fire was a loss of pressure in the air supply line that operates the tanker trailer's braking system. This caused the brakes to be applied and overheat, leading to a fire.

In this instance, the fire was intense and prolonged by the 26 tyres on the tanker trailer and dolly. The aluminium tanker shell melted and the ANE flowed from the tanker. However, it became trapped in the gully of the road and continued to be exposed to flames from the fire.

The fire decomposed the trapped ANE, causing its structure to break down and the fuel component to burn off. The resulting product, molten sensitised AN, continued to be exposed to fire, which led to the explosion occurring.

*Aerial drone image capturing the crater and the spray of rocks from the road, most pronounced, to the north of the crater (Credit: Gold Fields, Gruyere JV)*
