Government of **Western Australia**
Department of **Mines, Industry Regulation and Safety**
Dangerous Goods Safety

Incident investigation report

Ammonium nitrate emulsion tanker trailer explosion

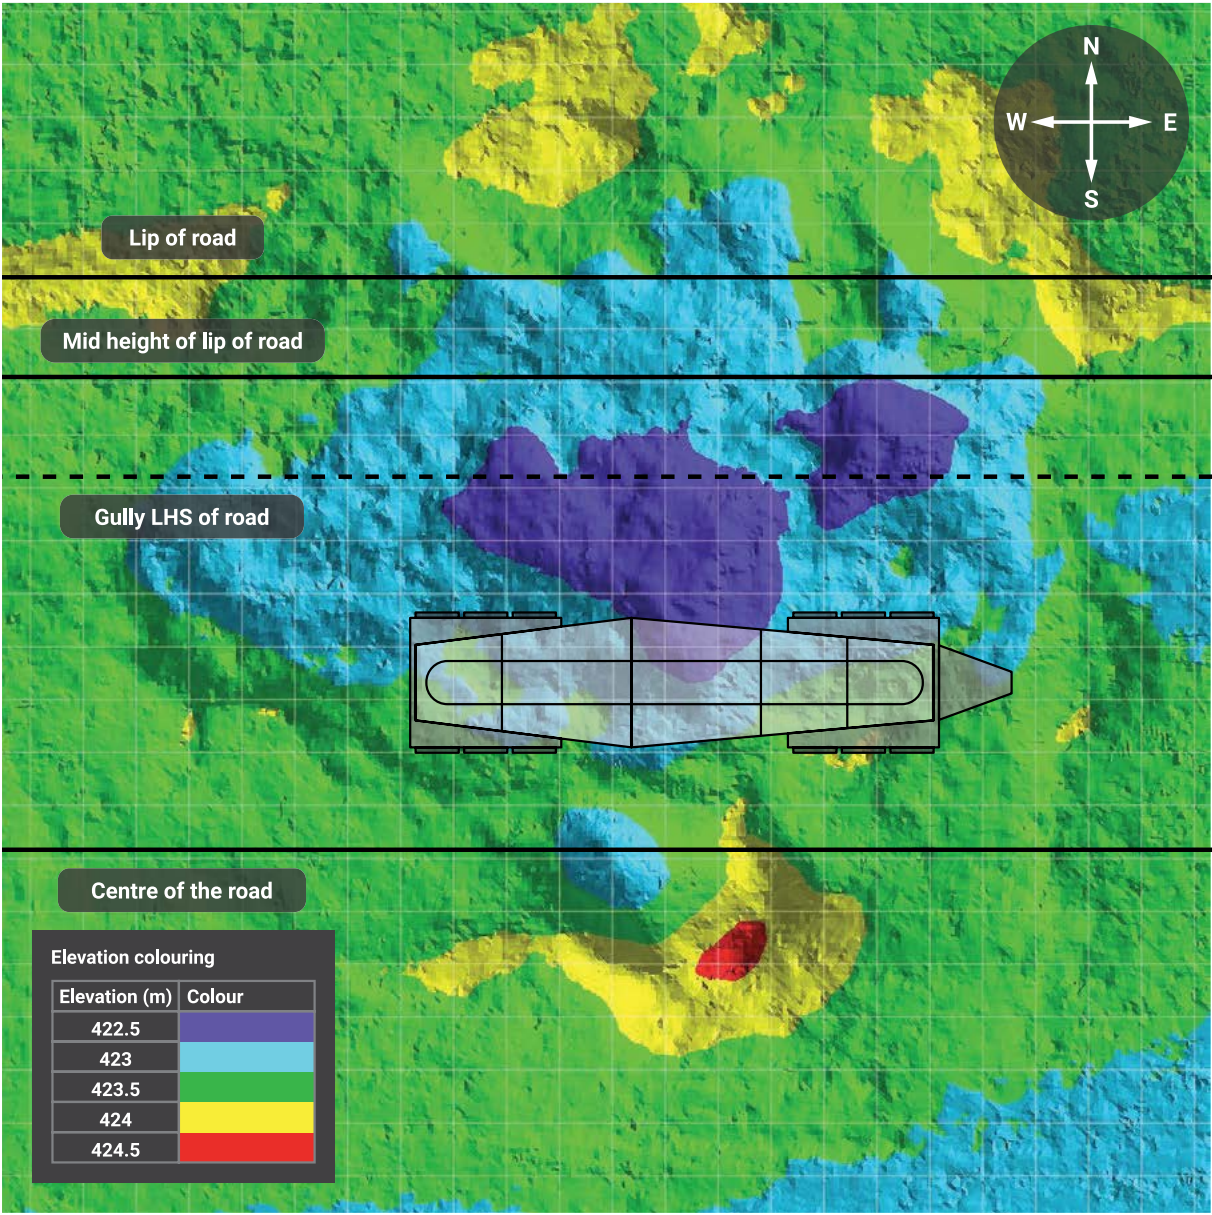
It should be noted that no ANE or AN was observed at the crater site prior to the backfilling, or after the site was examined more closely by the Department investigators.

Figure 5.6 Survey of the crater performed by Gold Fields, Gruyere JV. Overlaid is the estimated location of the tanker and dolly (Credit: Gold Fields, Gruyere JV)

Note: Each square represents 1 m x 1 m. Changes in colour are representative of 0.5 m depth change.

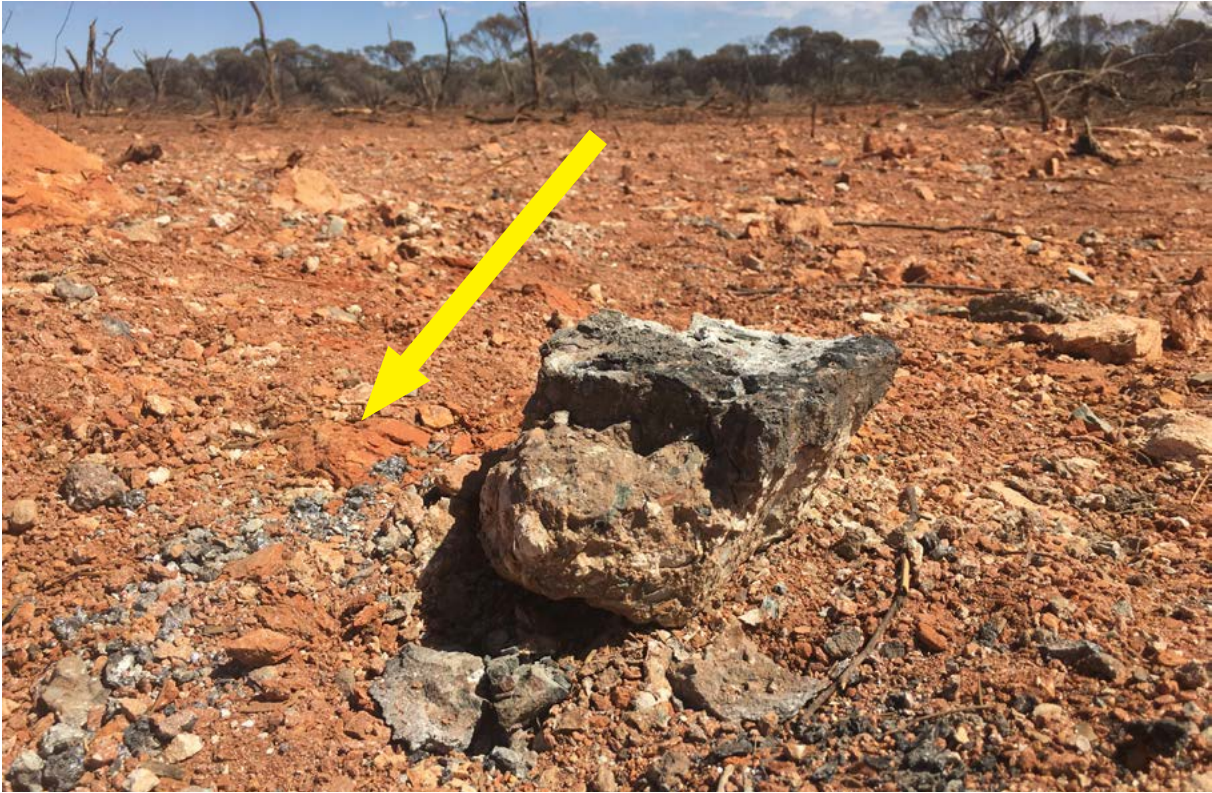
Figure 5.7 Image of sprayed rock (taken on northern side of road looking roughly north-north-west. Arrow points to molten aluminium. Large rocks are from the road surface. The surface next to the road is otherwise very sandy

Solidified molten aluminium is indicative that melting of the aluminium tank shell had occurred due to an intense fire prior to the explosion. A large piece can be seen within the crater from the images taken (Figures 5.10, 5.11 a and b). The density of molten aluminium is approximately 2.7 grams per cubic centimetre (g/cc) and would have pooled under the lighter decomposing AN mixture. Some of this aluminium was found within the crater following the explosion.

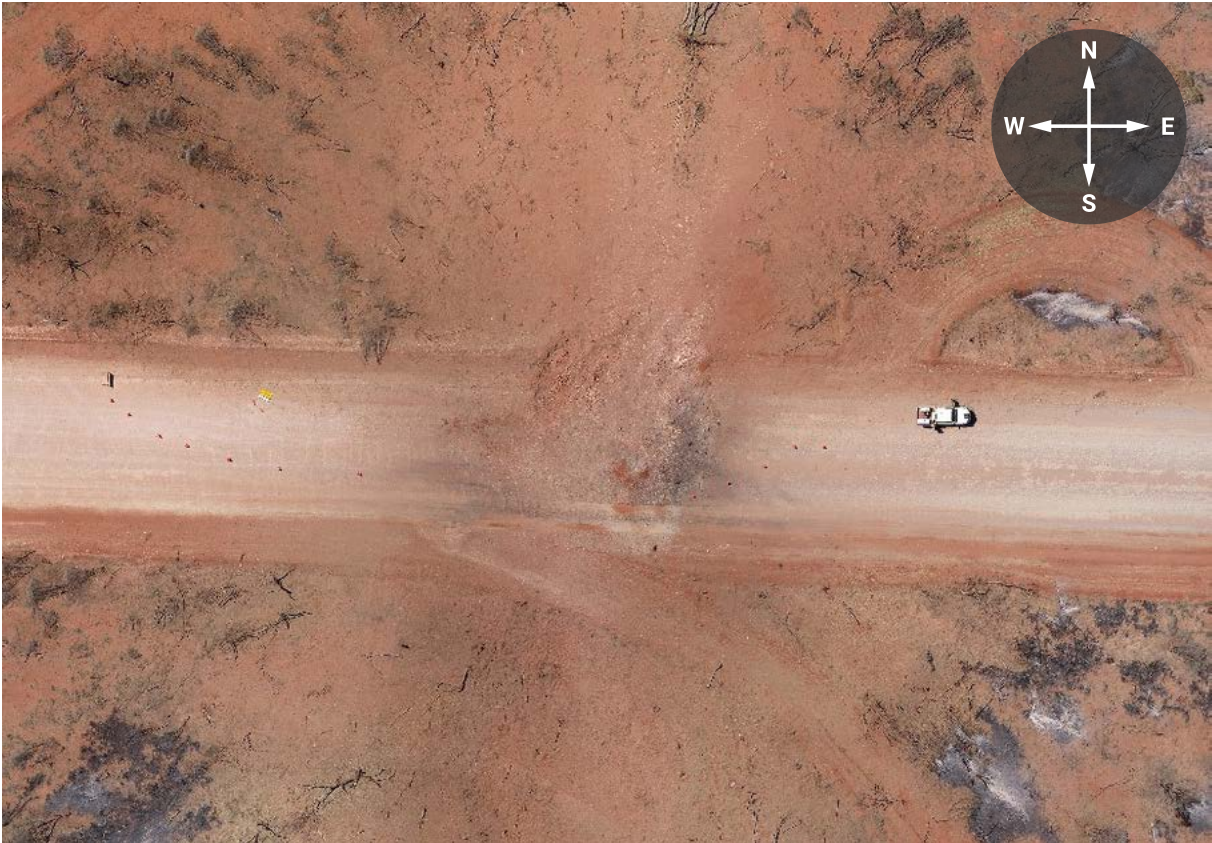
Figure 5.8 Aerial drone image capturing the crater and the spray of rocks from the road, most pronounced, to the north of the crater (Credit: Gold Fields, Gruyere JV)

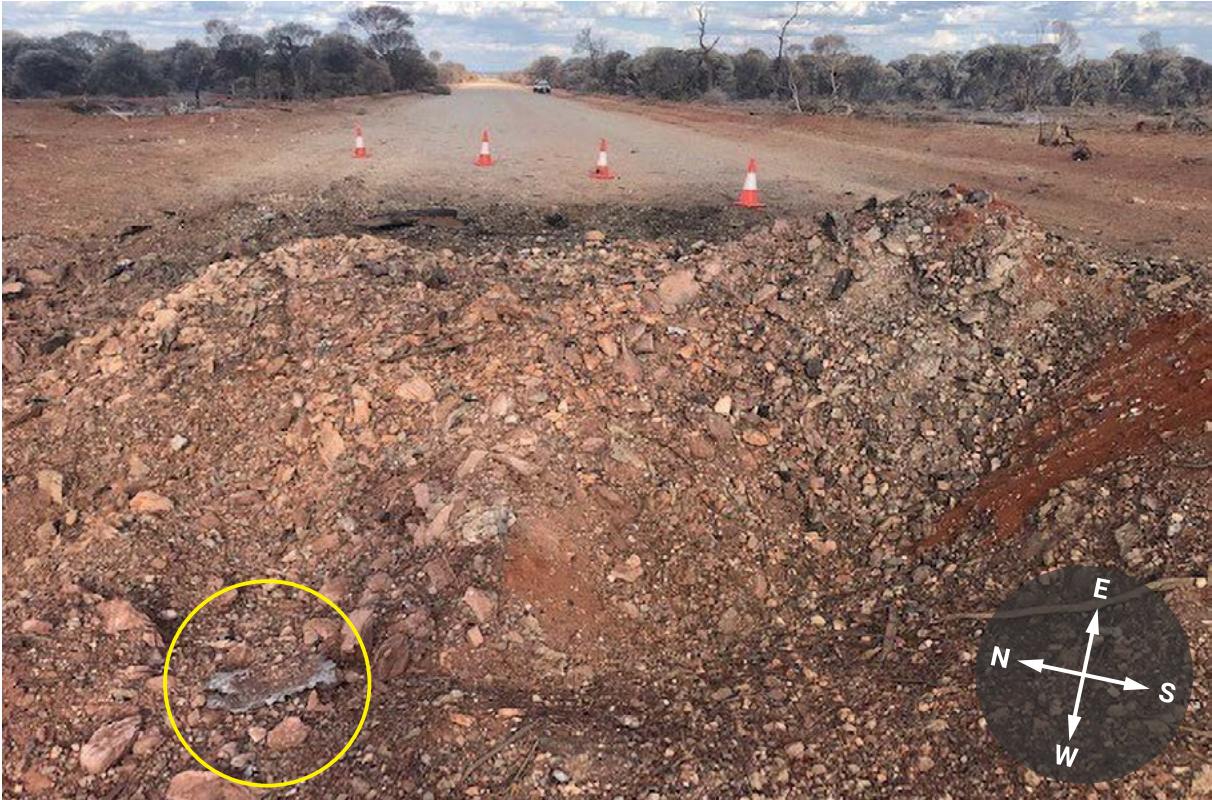
Figure 5.10 Image of crater looking east. Note solidified molten aluminium can be seen to the bottom left of the image (Credit: DFES)

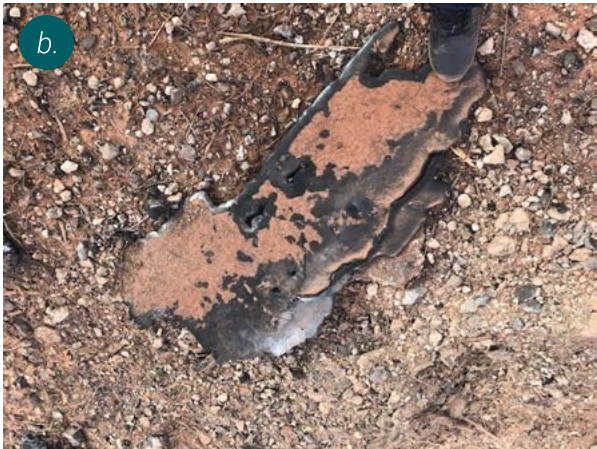
Figure 5.11 b Zoomed in image of solidified molten aluminium (Credit: DFES)

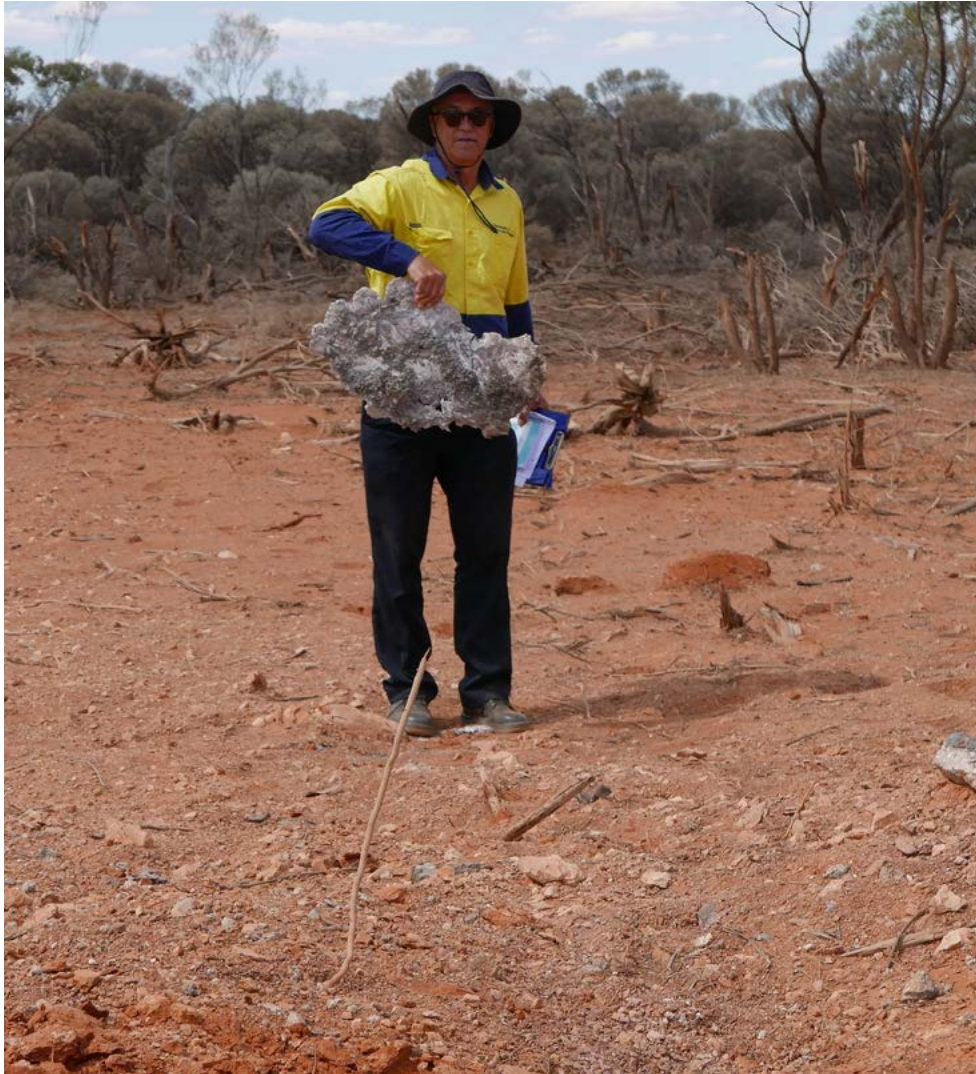
Figure 5.12 Solidified molten aluminium, located close to road when the investigation team attended site

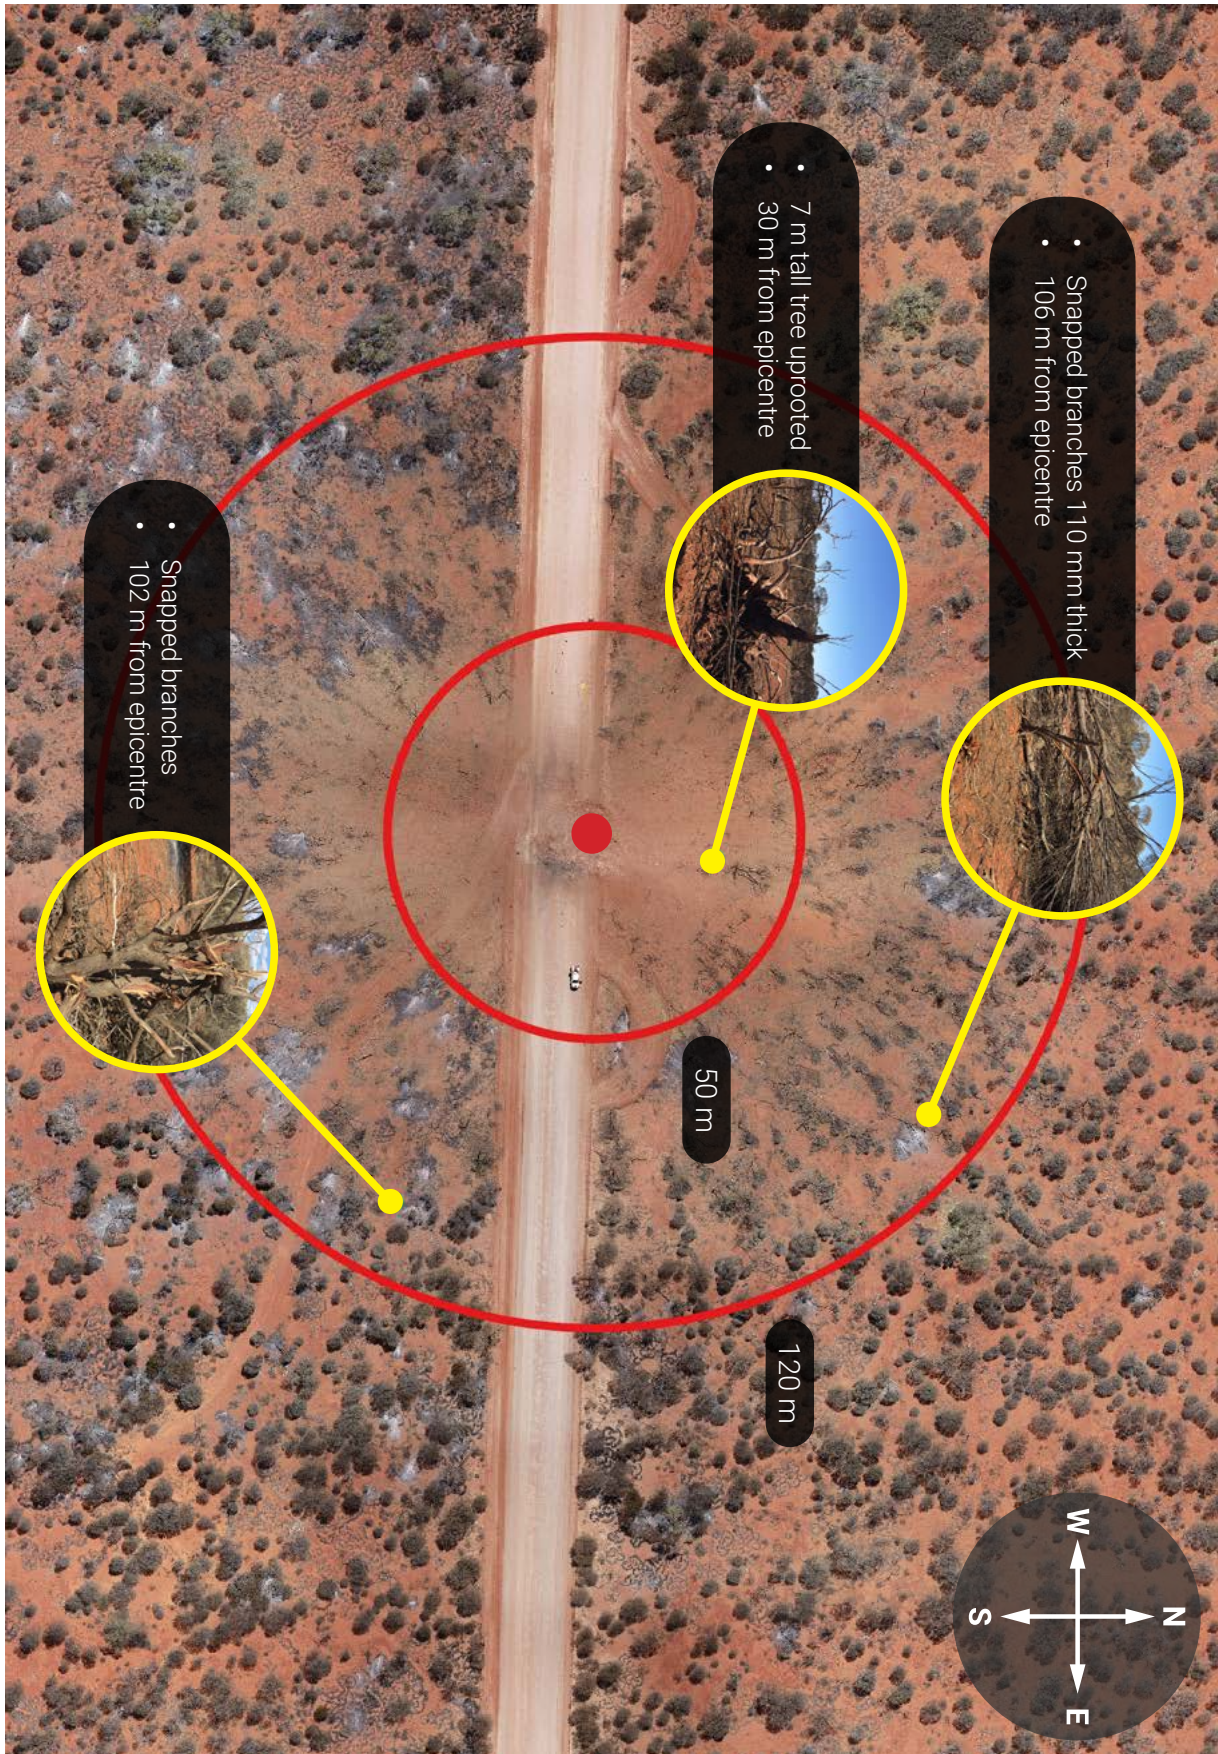
The blast wave damaged the surrounding bush. Two concentric circles of varying degrees of blast damage were observed. An inner circle of trees and shrubs up to a distance of 40-50 m were completely flattened and some trees up to 7 m high were uprooted by the blast wave.

A wider circle extended up to 120 m from the crater consisting of snapped branches, 75-110 mm thick. Beyond 120 m, the overpressure was too weak and branches remained intact. From this damage it was estimated that the blast overpressure at 120 m may have been of the order of 14 kPa, which gives a rough estimate of the size of the explosion of approximately 1-3 tonnes of TNT equivalent. This is a small fraction of the potential explosive power of the 33.85 tonnes of ANE initially present in the tanker trailer.

Figure 5.13 Blast overpressure effects on the surrounding landscape. Two distinct circles were formed, markers here are at 50 and 120 m from the epicentre (Credit: Gold Fields, Gruyere JV; annotated by the Department)

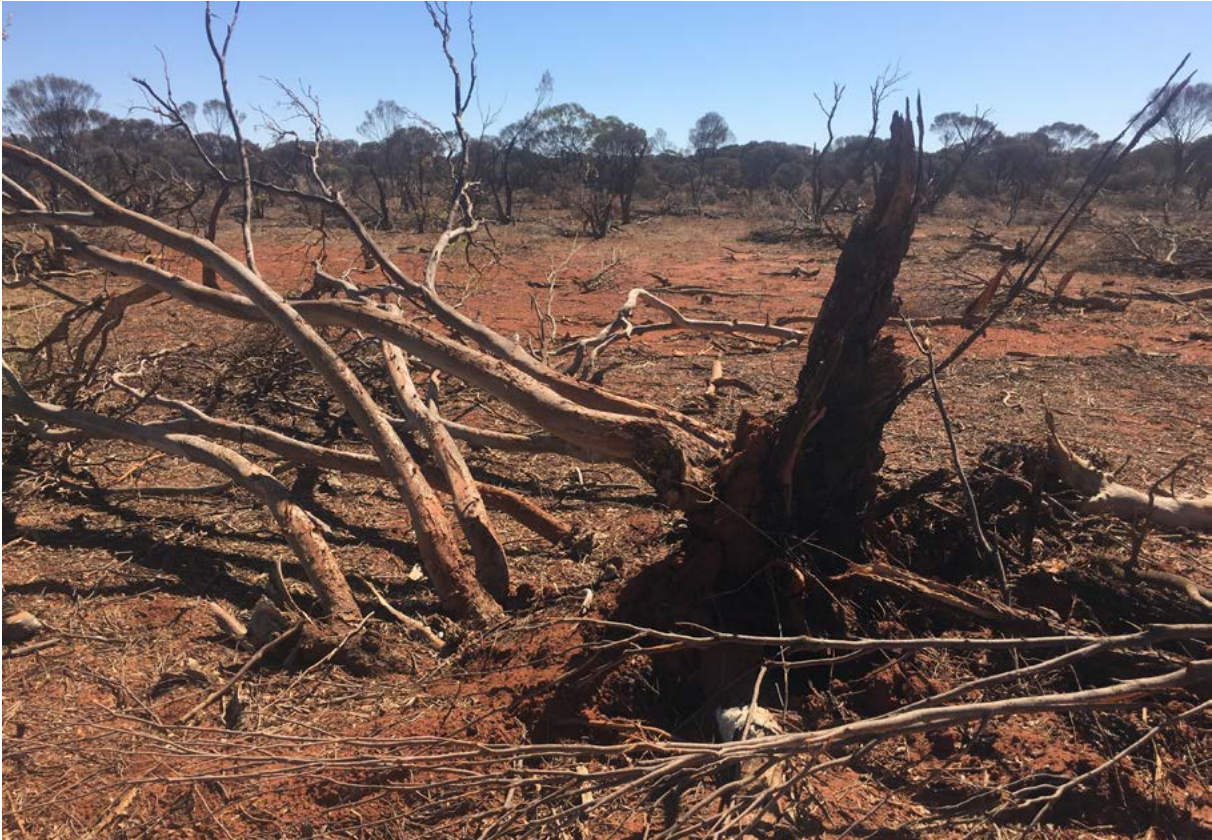
Figure 5.14 Photo of uprooted tree 7 m high located 30 m from the epicentre of the explosion

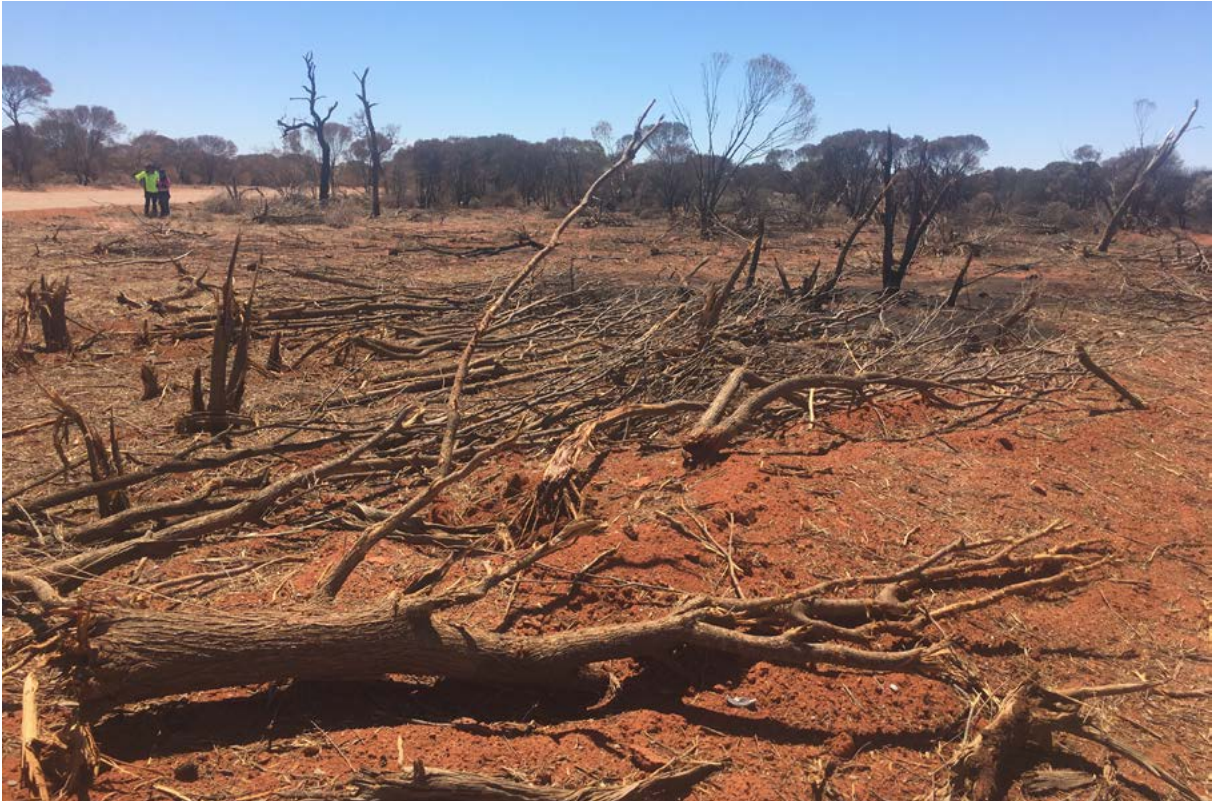
Figure 5.15 Photo of trees destroyed by the blast up to 50 m from the epicentre (up to 125 mm diameter trunks)

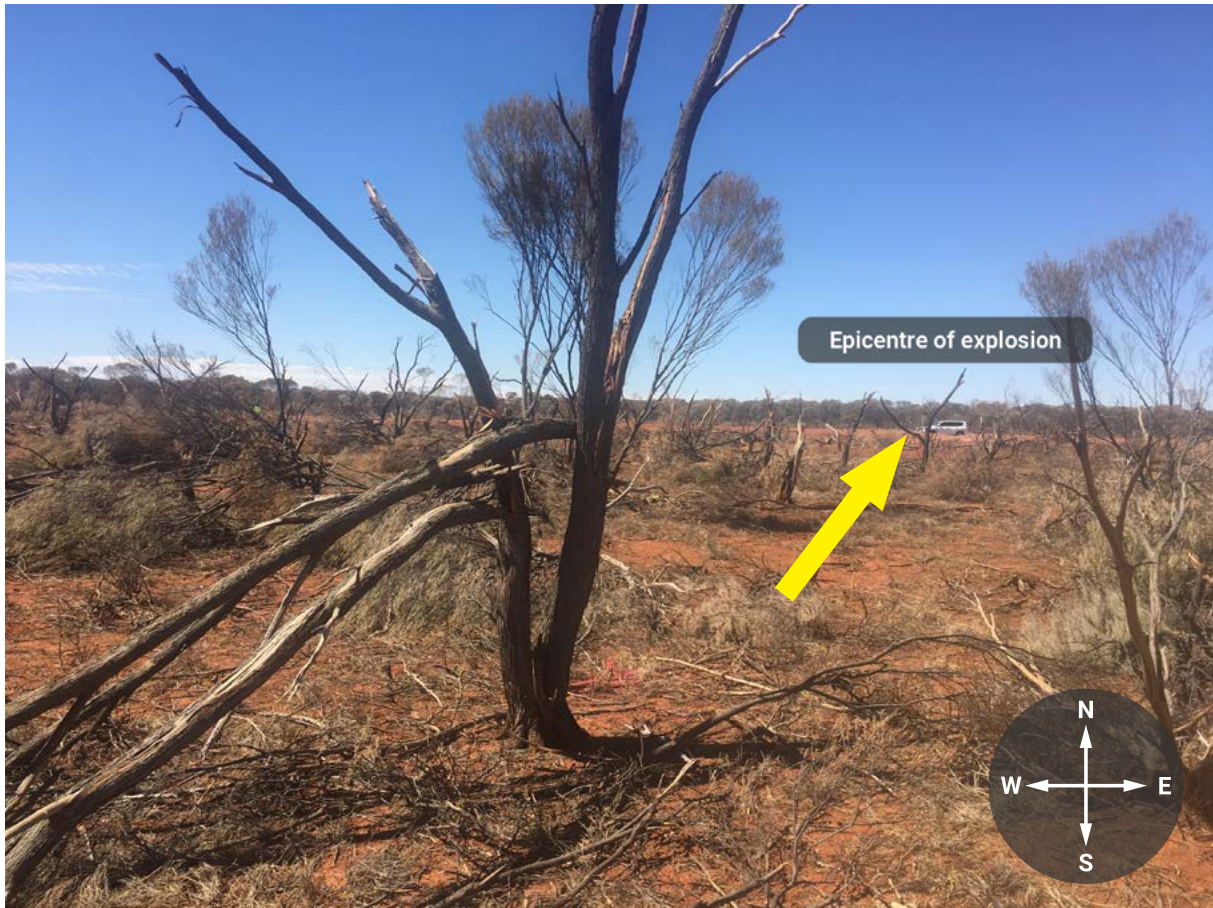
Figure 5.16 Photo of trees damaged by the blast at 100 m from the epicentre. Branches 110 mm in diameter branches are snapped. Arrow indicates location of epicentre

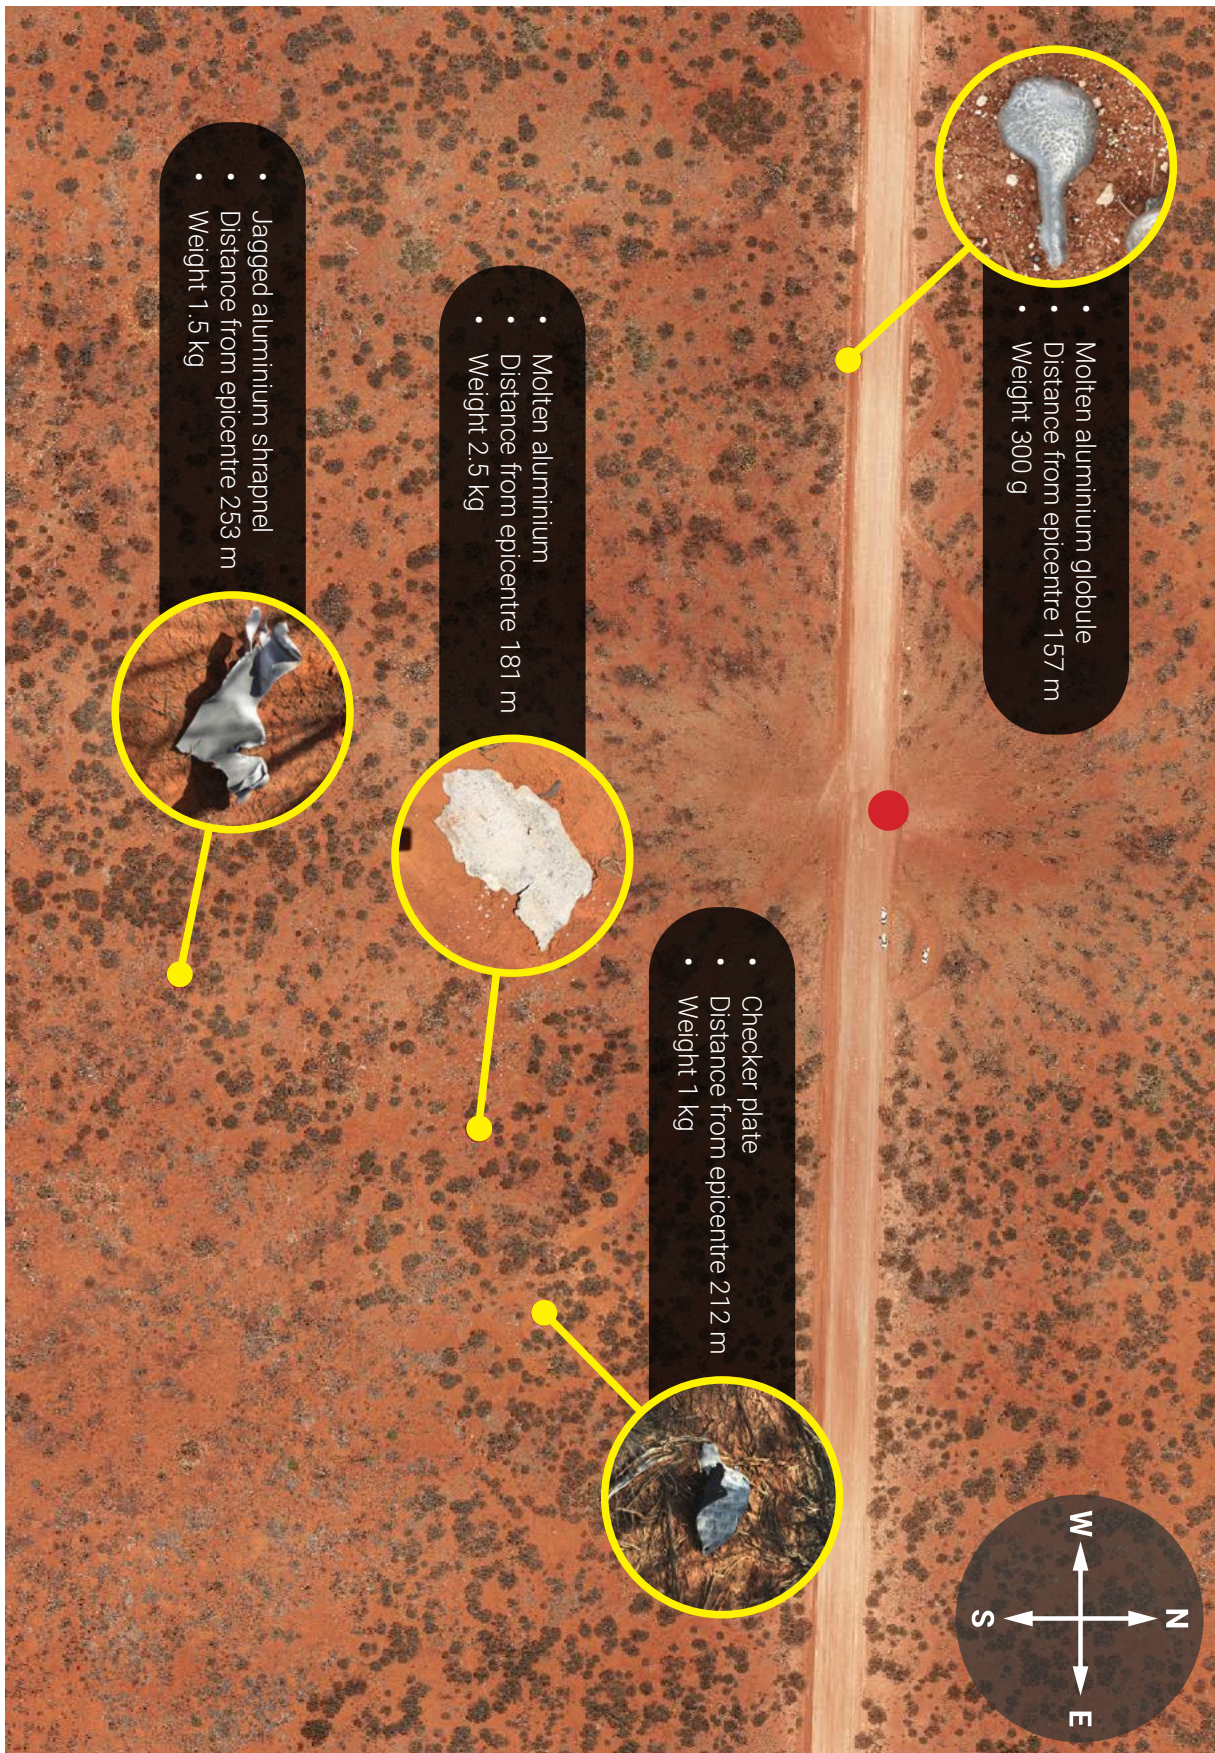
Figure 5.21 Various forms of aluminium shrapnel found at the scene, weight and location from the epicentre of the explosion (Credit: Gold Fields, Gruyere JV; annotated by the Department)

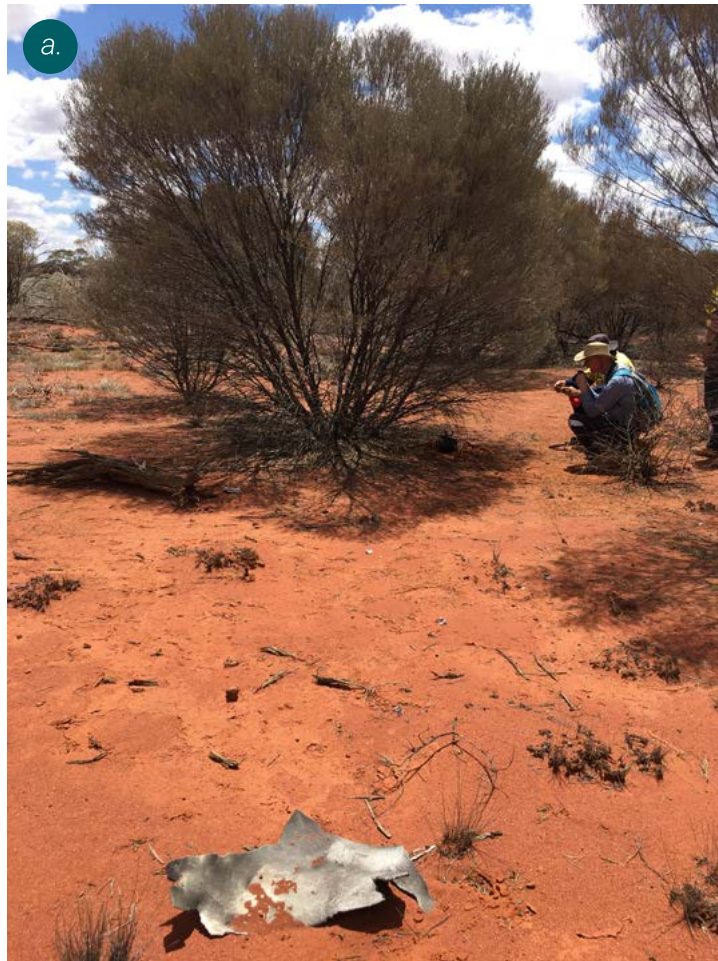
Figure 5.22a Aluminium fragment from intact section of tanker shell found to the south-south-east of the blast

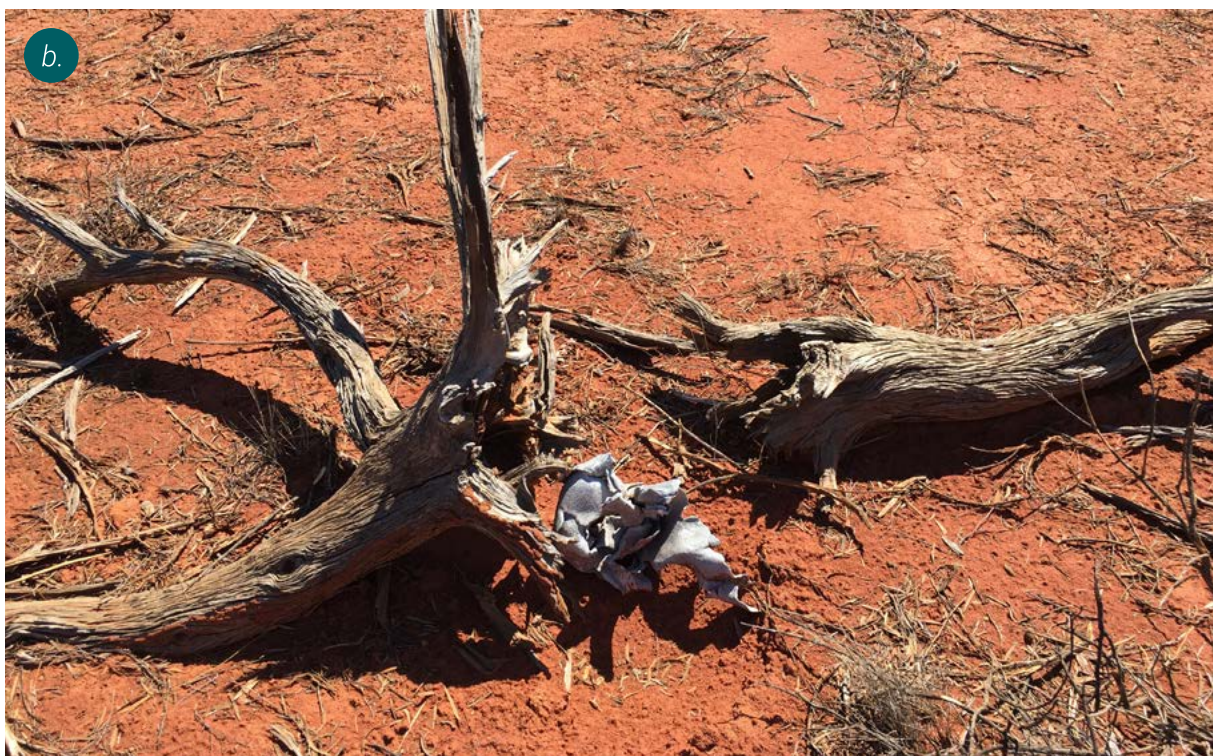
Figure 5.22b Aluminium shrapnel found at approximately 50 m to NW of the epicentre of the explosion

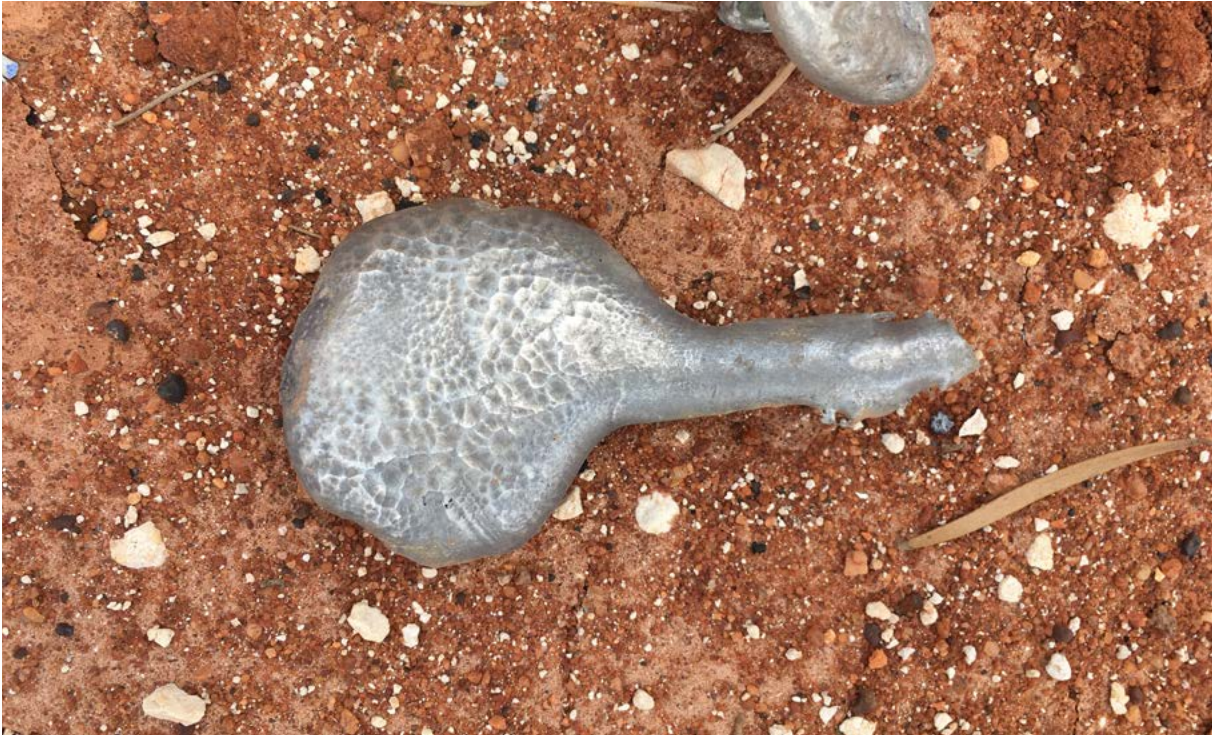
Figure 5.23 *Image of molten aluminium pieces approximately 10 cm in length located 157 m west of the epicentre*

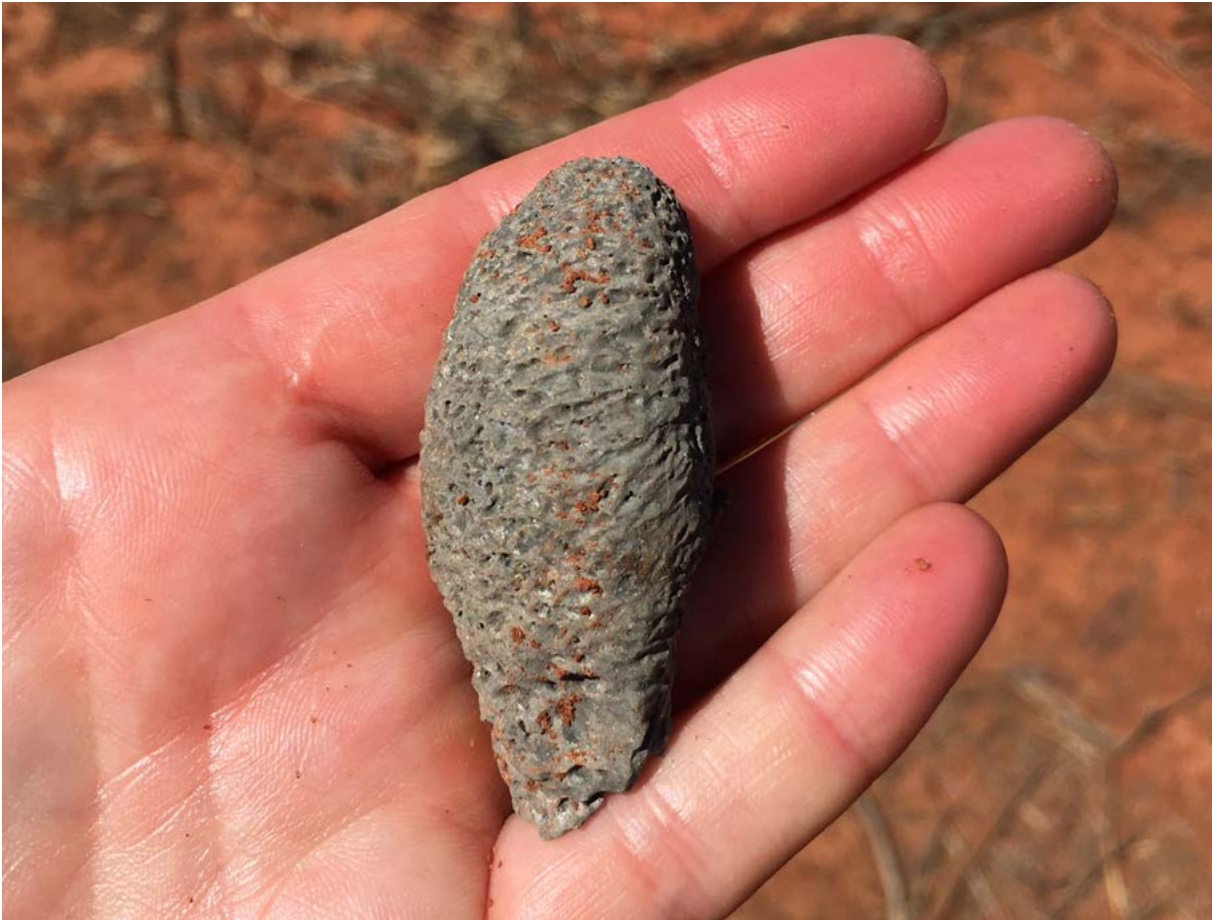
Figure 5.24 *Another piece of solidified molten aluminium, pitted by the cooling on the ground and formed into a ball like structure*

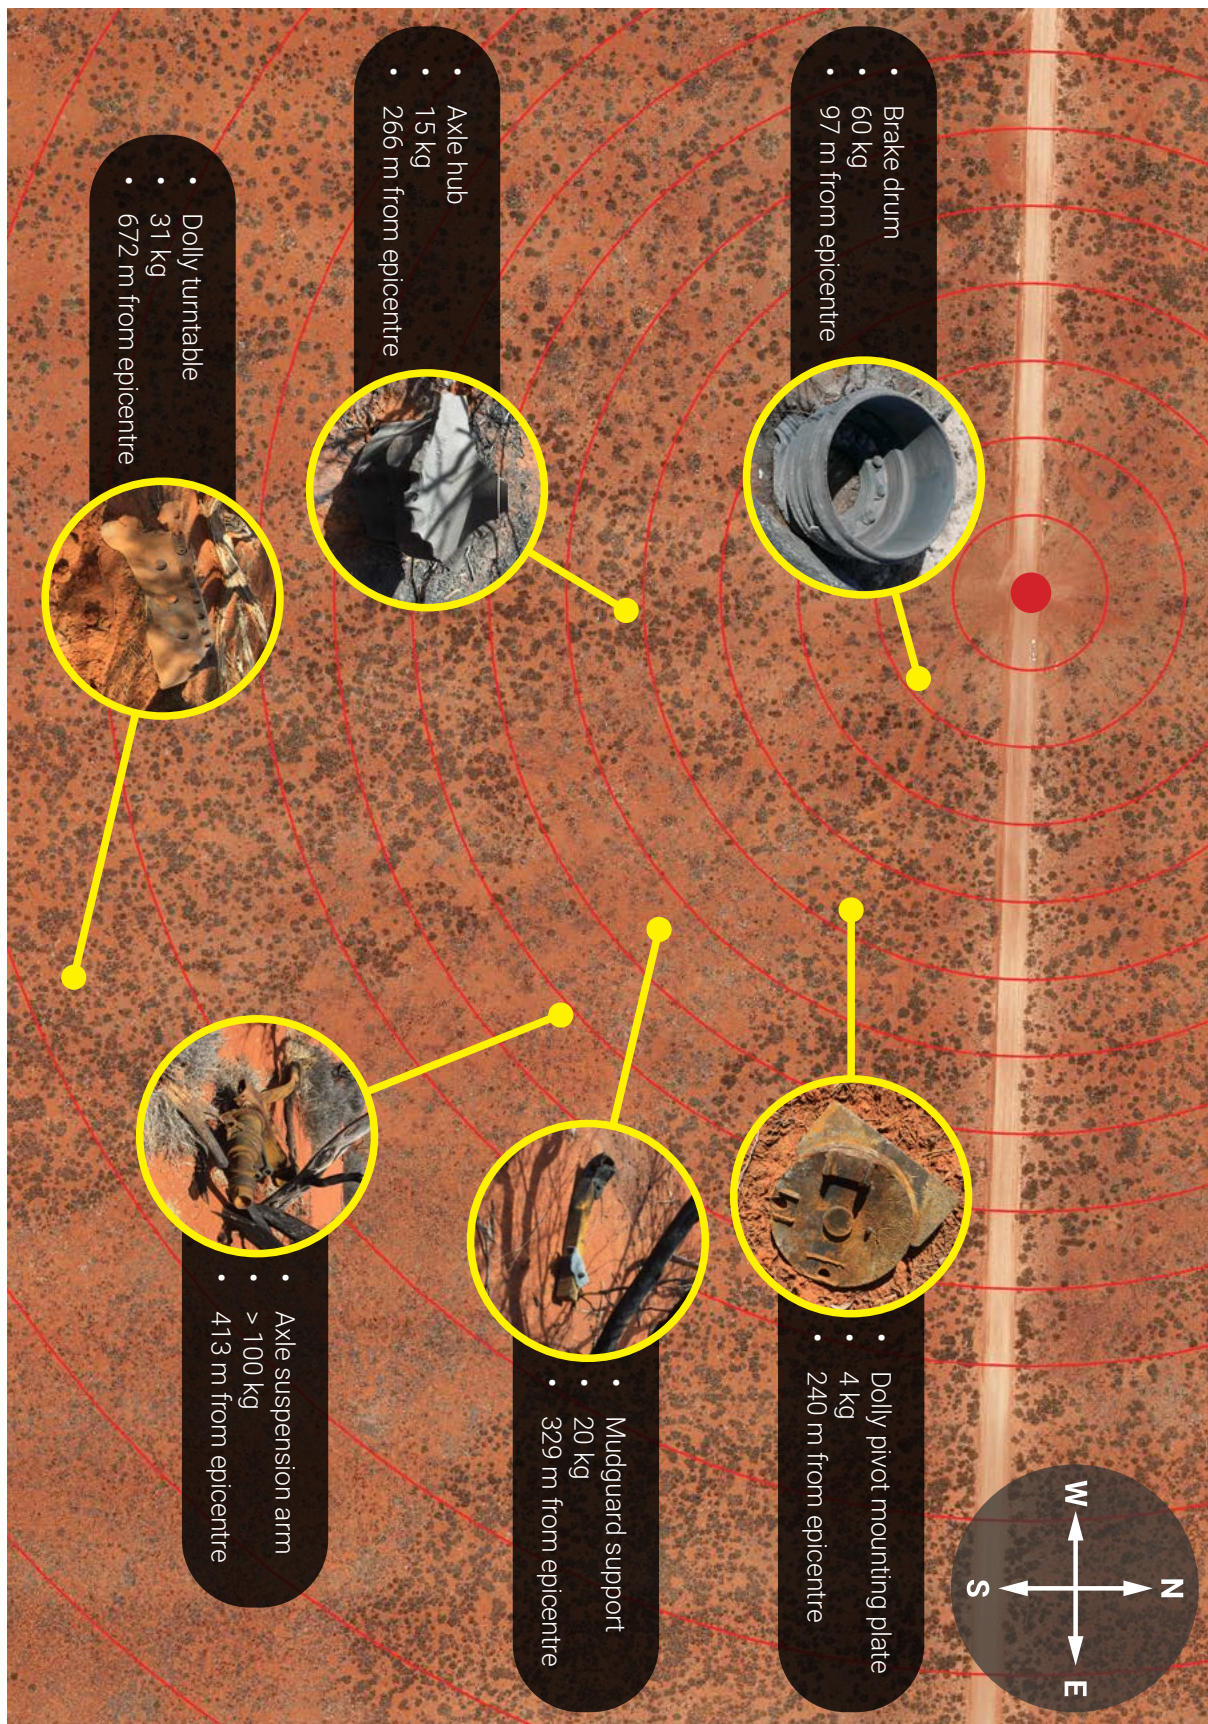
The largest pieces of steel shrapnel found were a piece of a dolly axle suspension arm in excess of 100 kg at 413 m from the blast site, a 60 kg brake drum at 97 m and a 31 kg piece from the dolly turntable at 672 m, all located in a south-easterly direction from the crater. The 31 kg piece from the dolly turntable was almost fully embedded within the soil when located, consistent with a ground-based explosion.

Figure 5.25 Significant and identifiable steel pieces located at the incident scene. The red marker indicates epicentre of explosion. The red circles indicate the distance in 50 m intervals to 500 m from the epicentre of the explosion, and then at 100 m intervals from then on (Credit: Gold Fields, Gruyere JV; annotated by the Department).

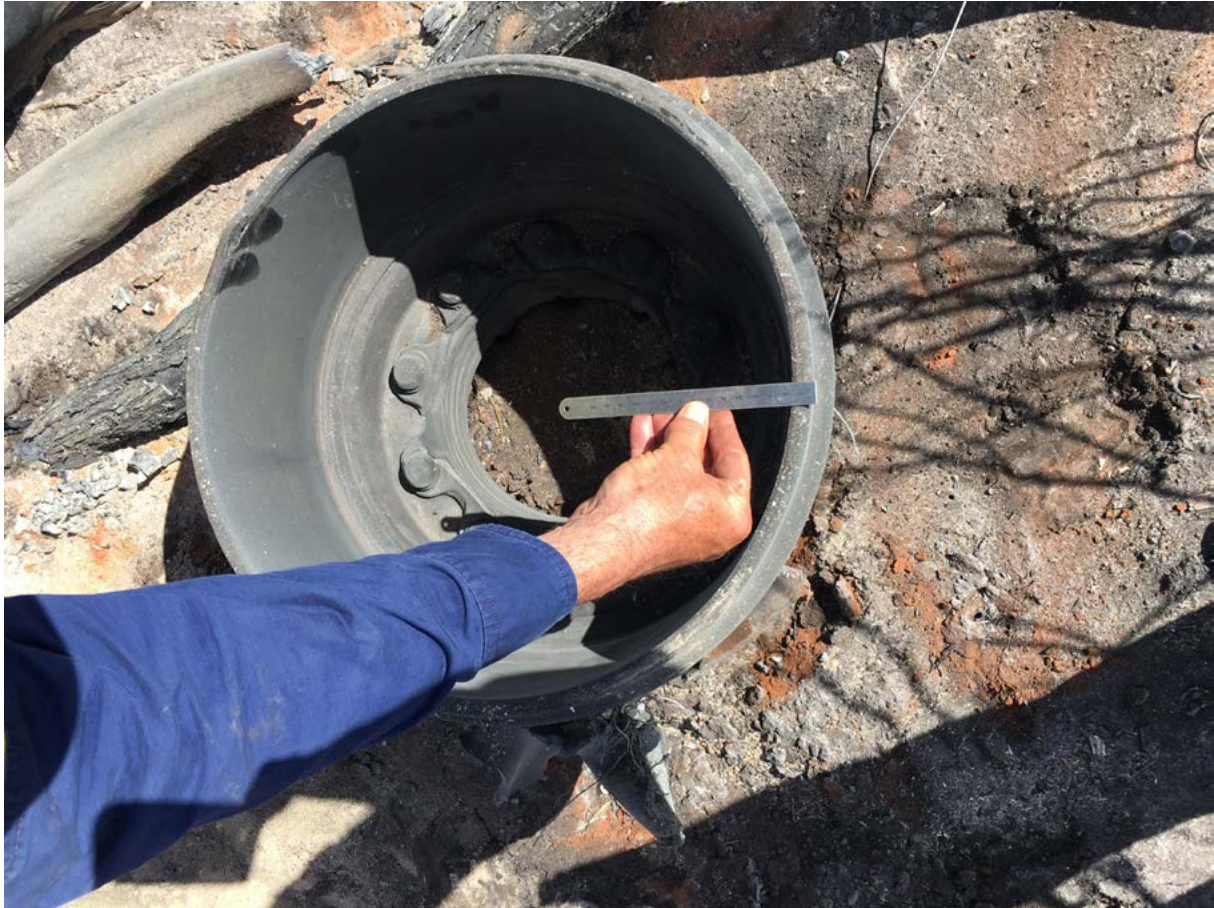
Figure 5.26 Brake drum weighing 60 kg located 97 m south-east of the epicentre of the blast

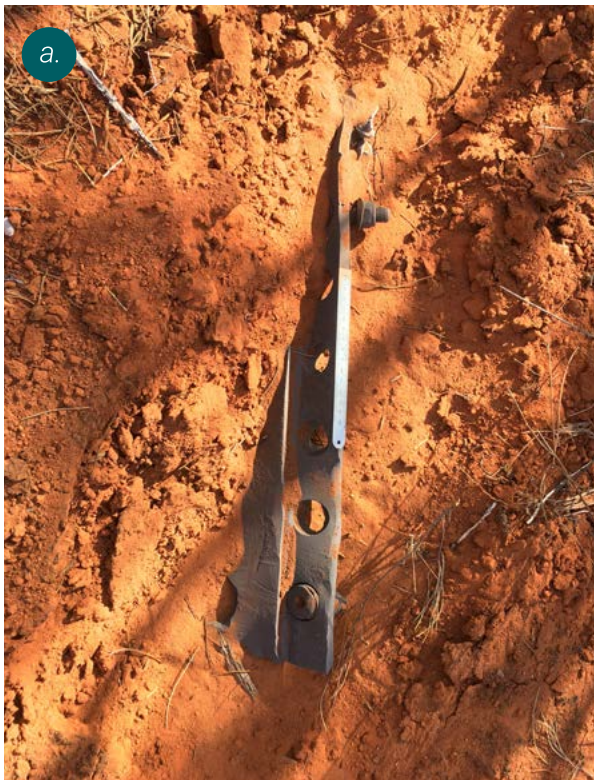
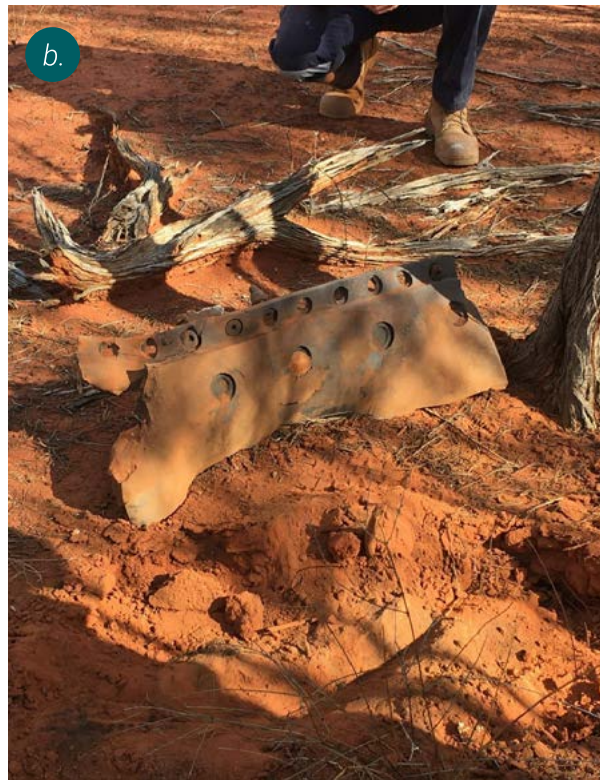
Figures 5.27 a and b Piece of dolly turntable, weighing 31 kg, found embedded within the ground at 672 m from the epicentre of the explosion
