Government of **Western Australia**
Department of **Mines, Industry Regulation and Safety**
Dangerous Goods Safety

Incident investigation report

Ammonium nitrate emulsion tanker trailer explosion

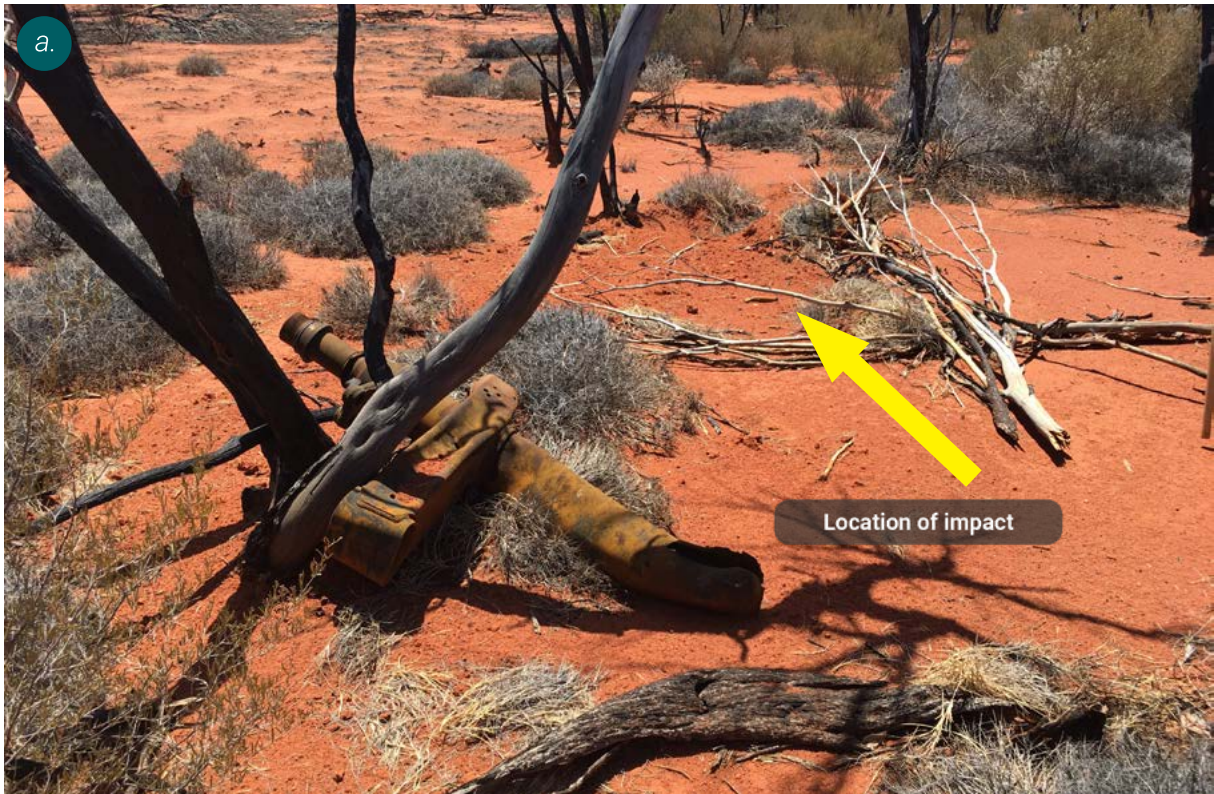
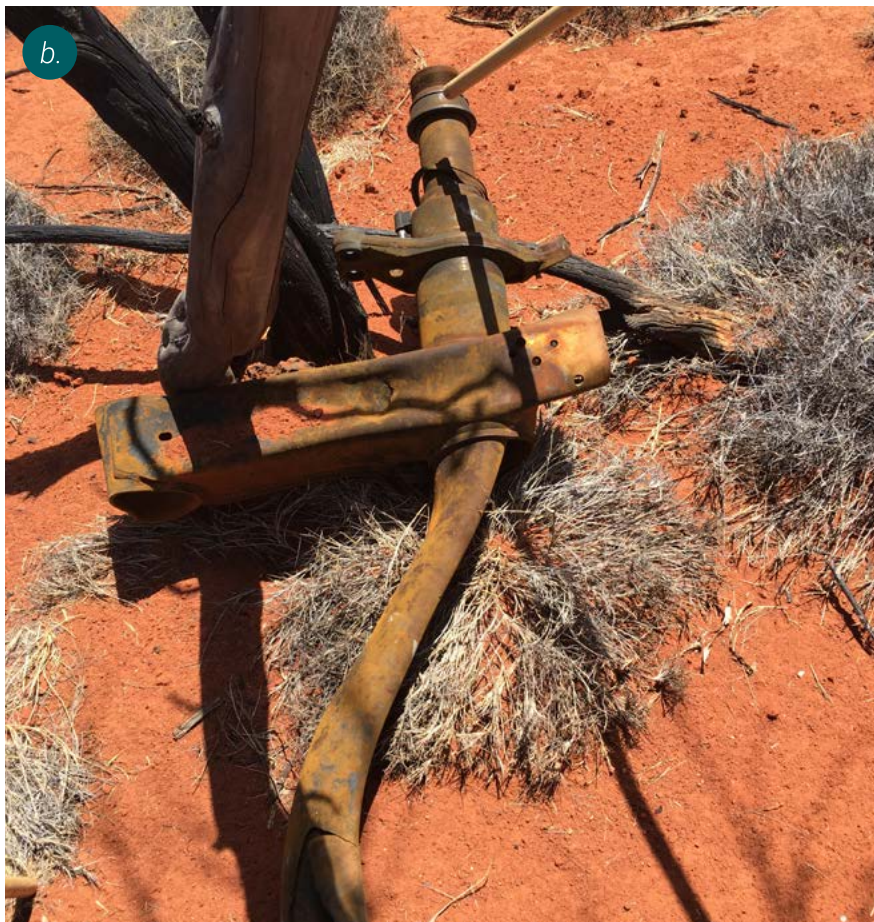
Figures 5.28 a and b Axle suspension arm from dolly (weighing in excess of 100 kg)

Note: The disturbed ground approximately 3 m to the north of it. Located 420 m from the epicentre of the blast.

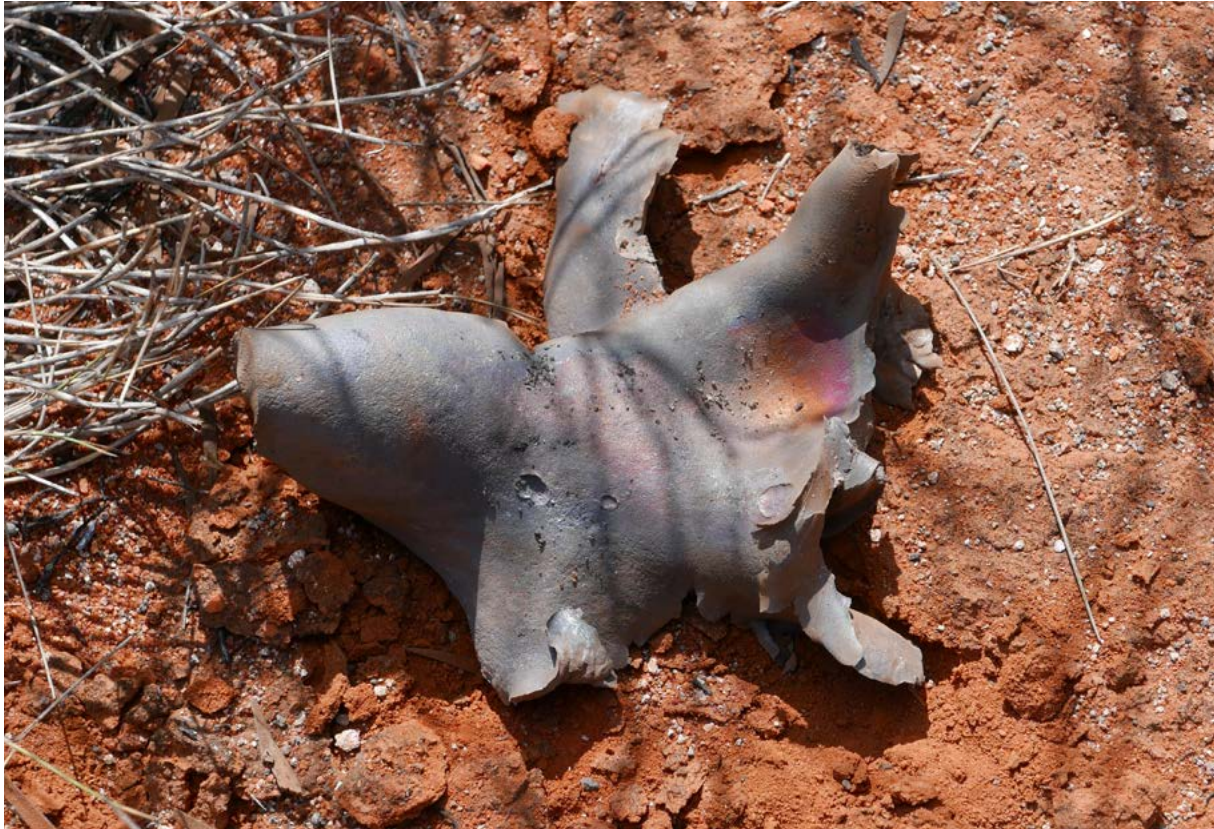
Figure 5.29 Steel piece of shrapnel (approximately 20 cm) with noticeable softening effects on the edges from the fire. Piece located at 304 m south-south-east of the epicentre of the explosion

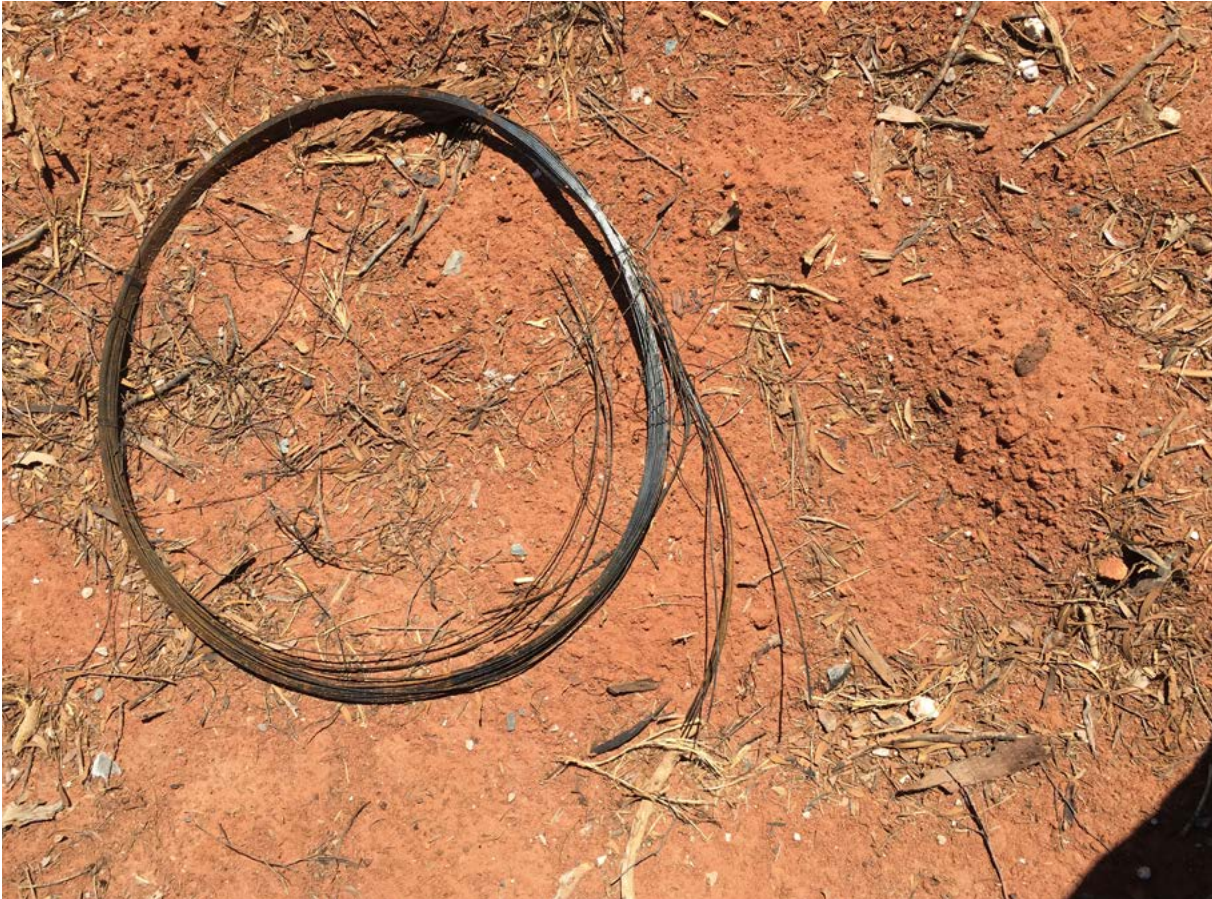
Figure 5.30 Inner steel radials used to reinforce tyre located within a 30 m distance from the epicentre of the explosion. Two spools were located within close proximity of one another

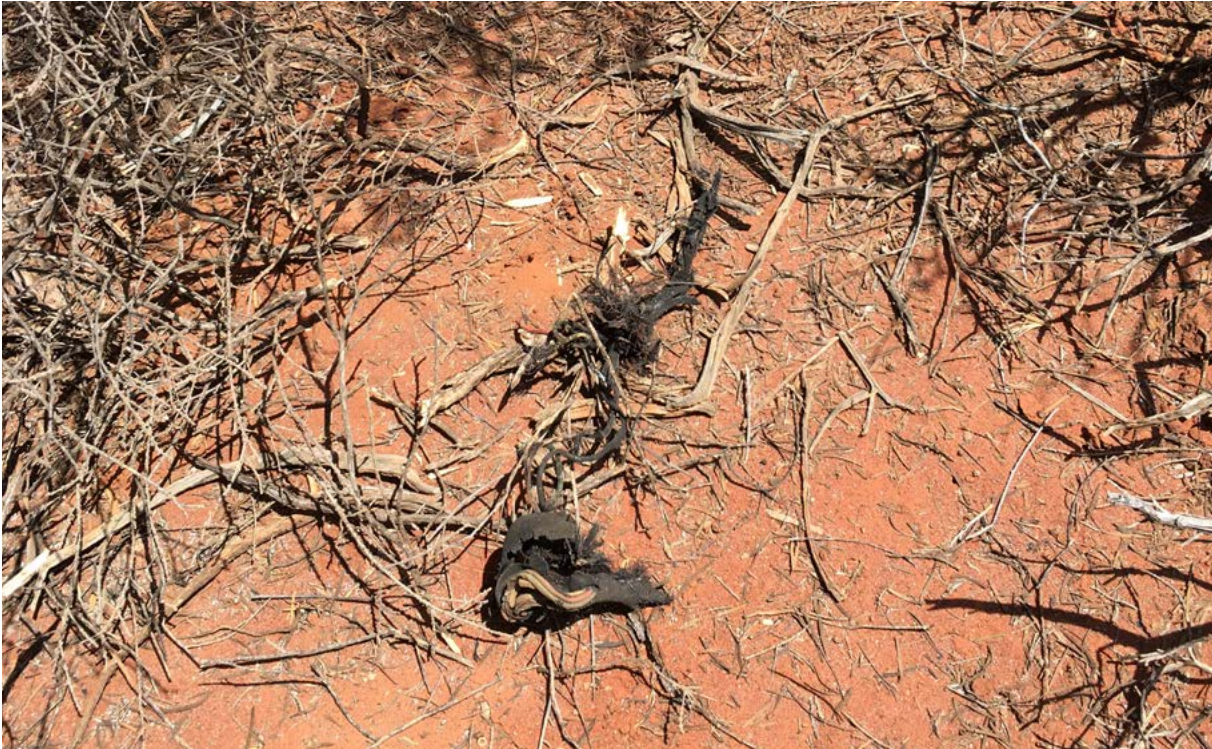
Figure 5.31 Fire damaged electrical cabling 132 m east-south-east of the epicentre of the explosion

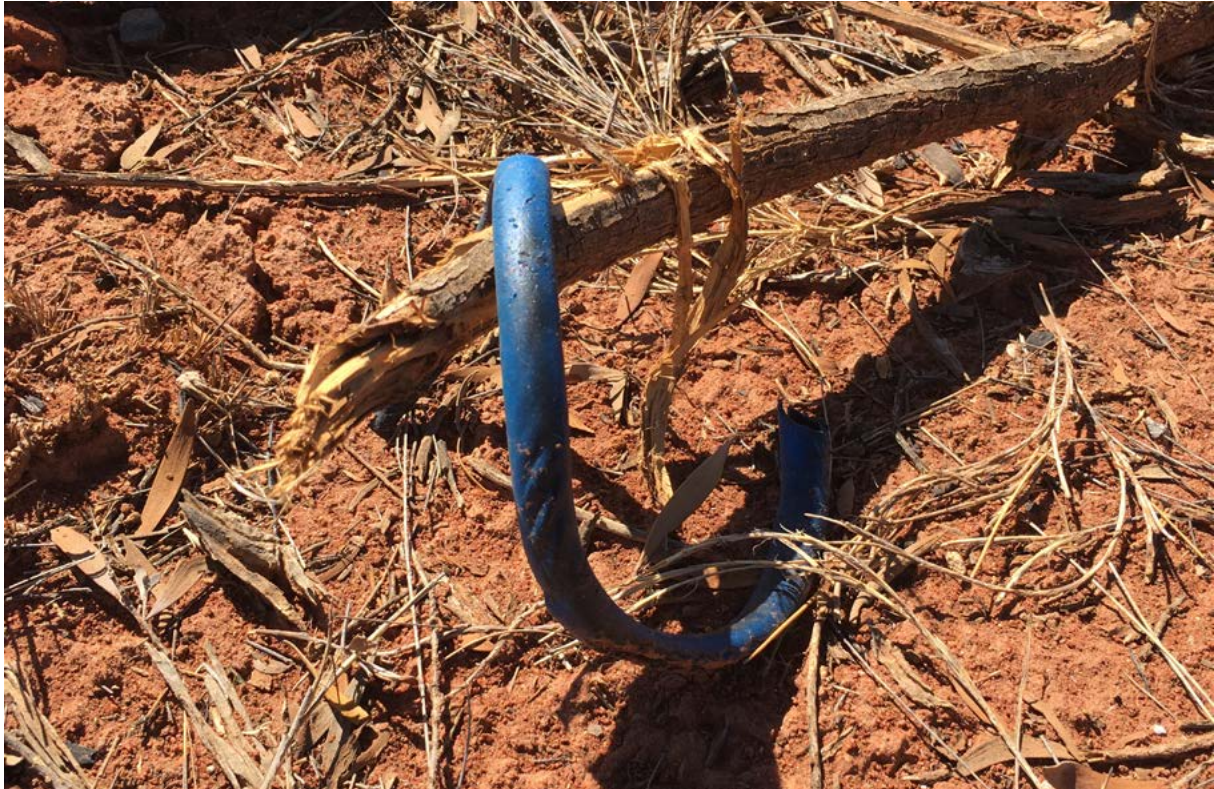
Figure 5.32 Air supply line cable located 61 m from the explosion site in an east-south-east direction. As it is relatively unscathed, it is thought that this was located towards the front of the dolly's draw bar and less subjected to fire

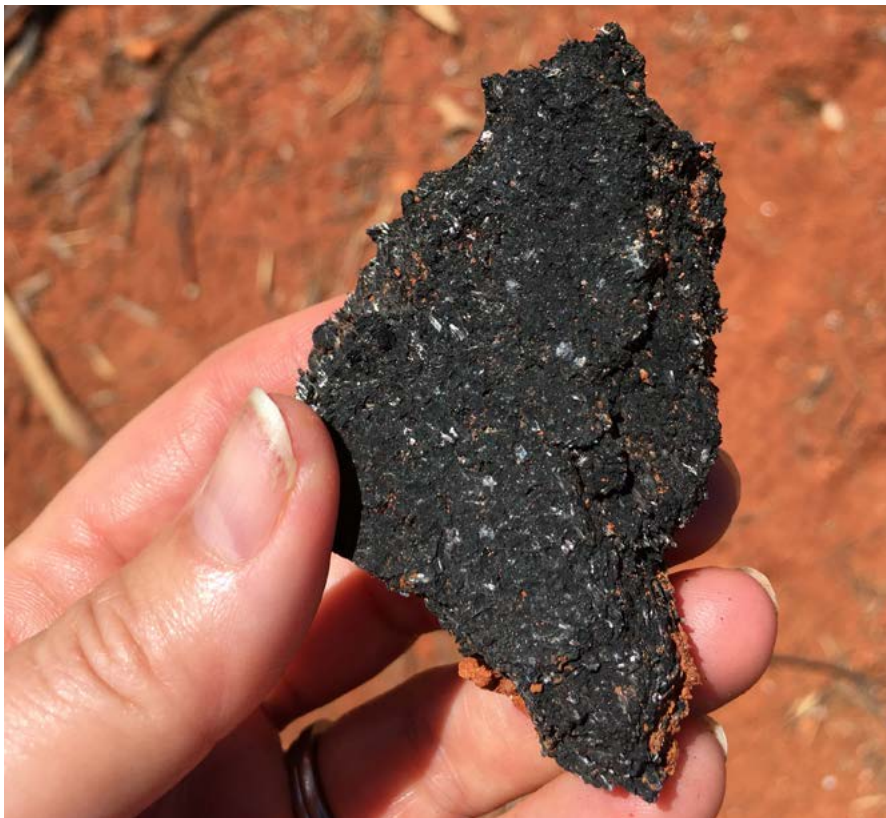
Figure 5.33 Tyre fragment that has been affected by fire located 66 m from epicentre in south-south-east direction

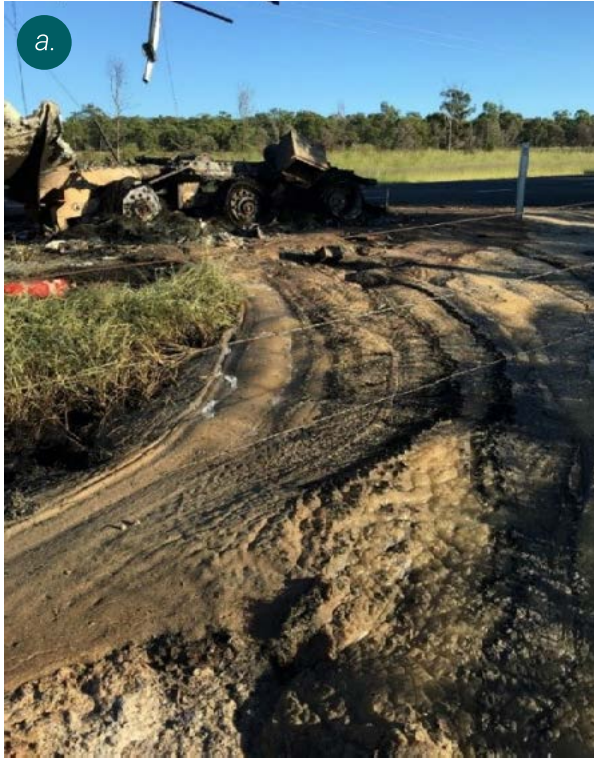
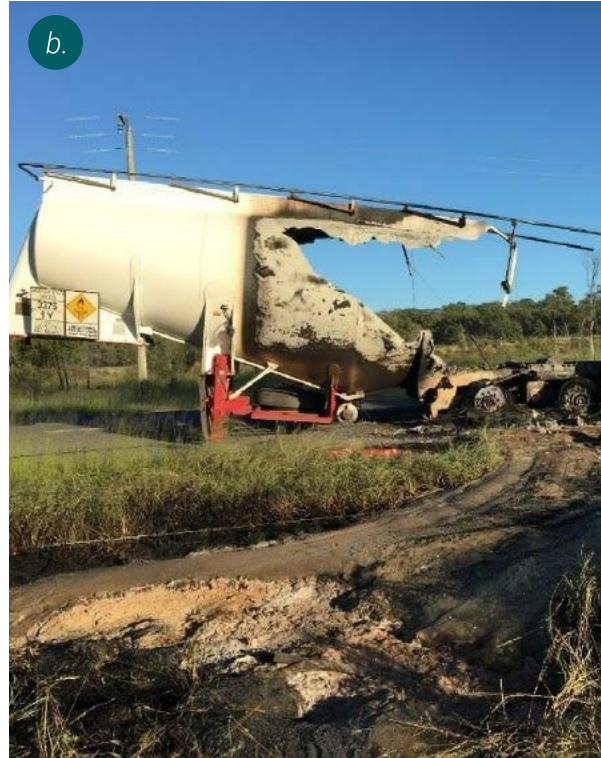
Figures 7.1 a and b Images of tanker trailer. This shows the flow of bulk unchanged ANE (i.e. had not undergone significant decomposition) that had escaped from the aluminium shell and was away from the tyre fire

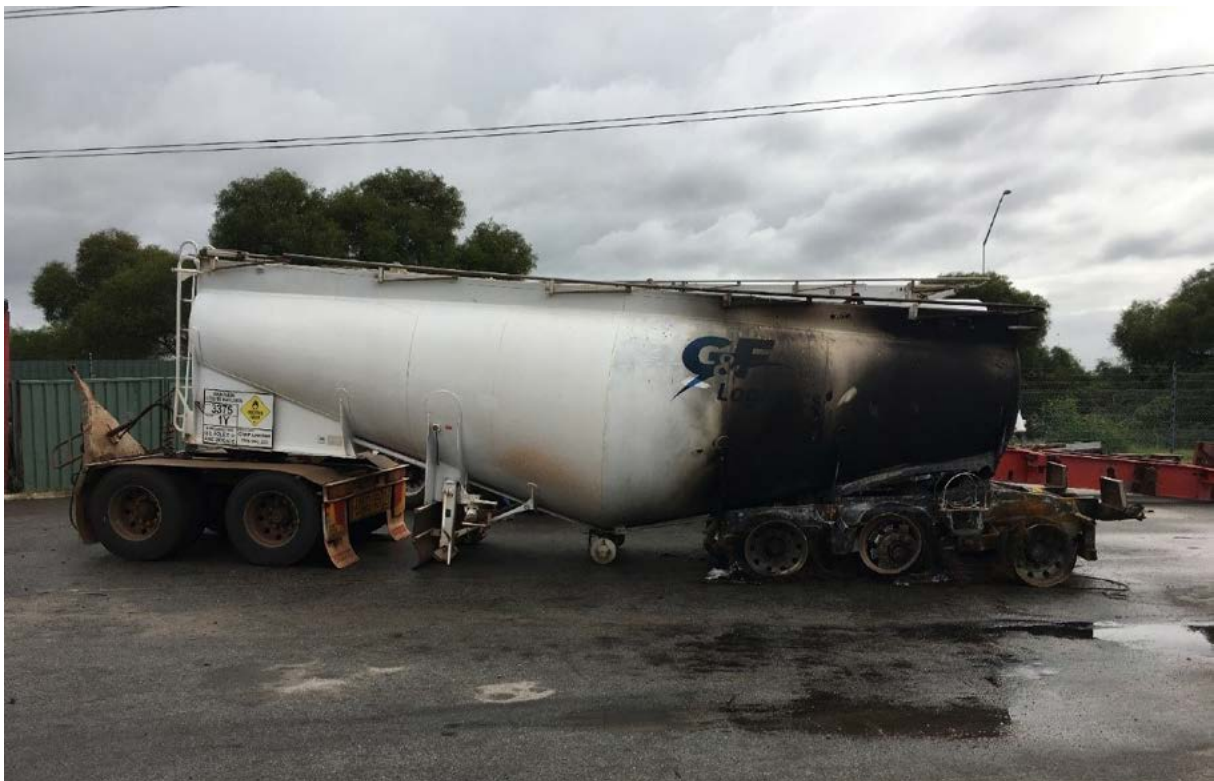
Figure 7.2 Tyre fire on the ANE tanker caused by wheel bearing failure

Mudguards with heat shielding properties (e.g. stainless steel) should be fitted, to protect the tank or cargo containing 'AN explosion risk goods' from the heat radiation of a tyre fire.

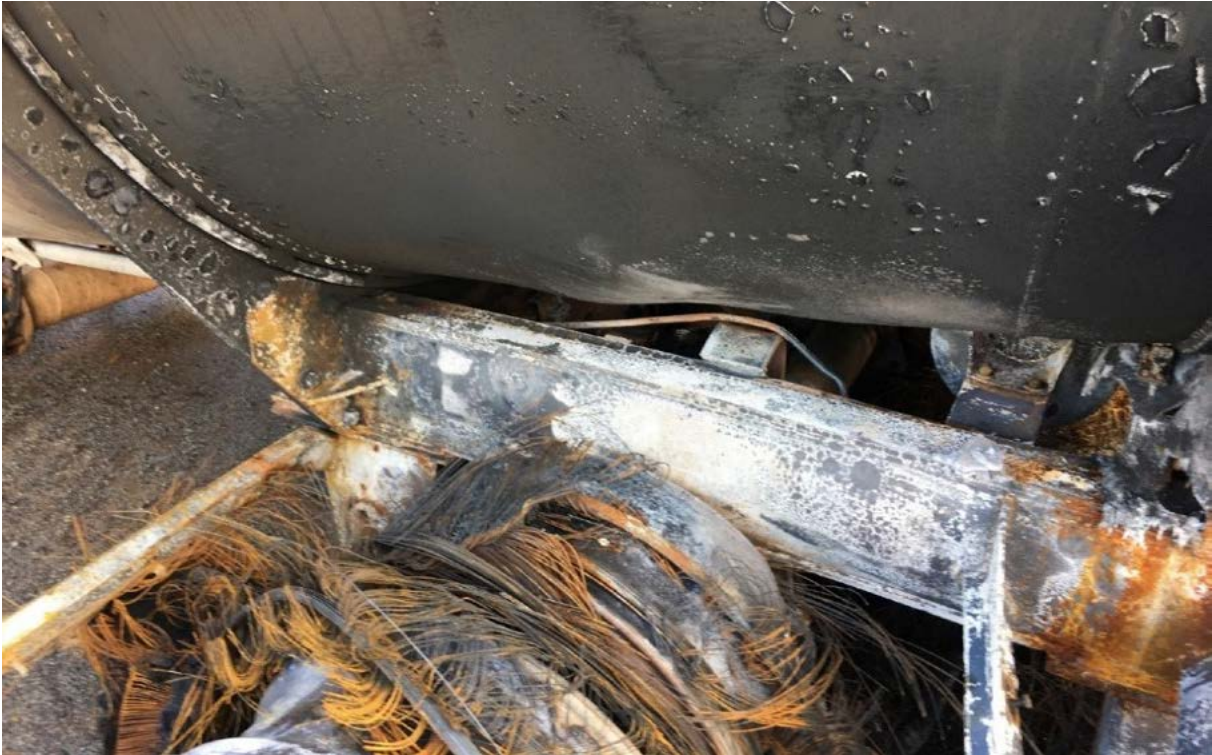
Figure 7.3 Tanker shell starting to buckle caused by the fire

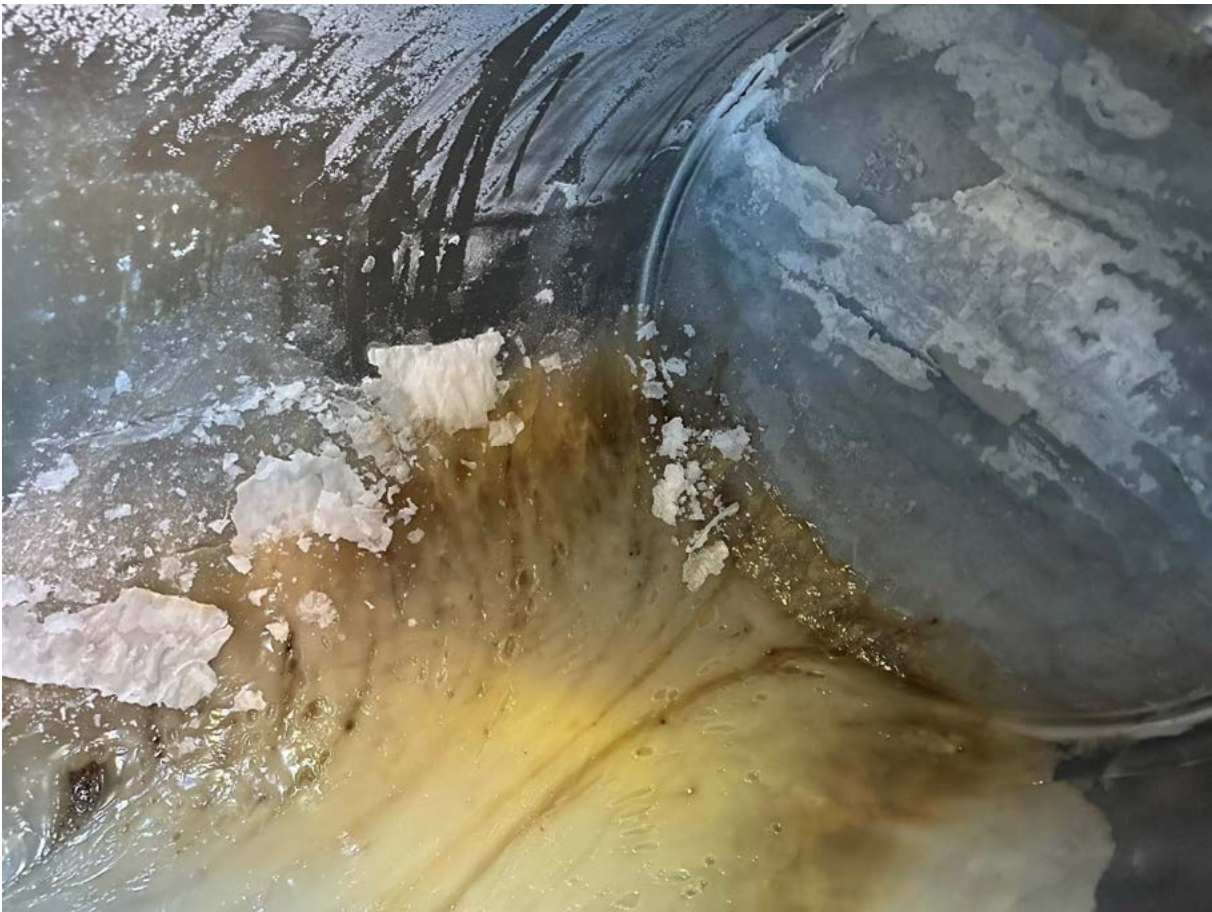
Figure 7.4 Inside walls of the tanker after the bulk of the ANE had been transferred. Solid AN formed on the sides where the fire impinged on the tanker. Some discolouration and possible separation of the product has occurred

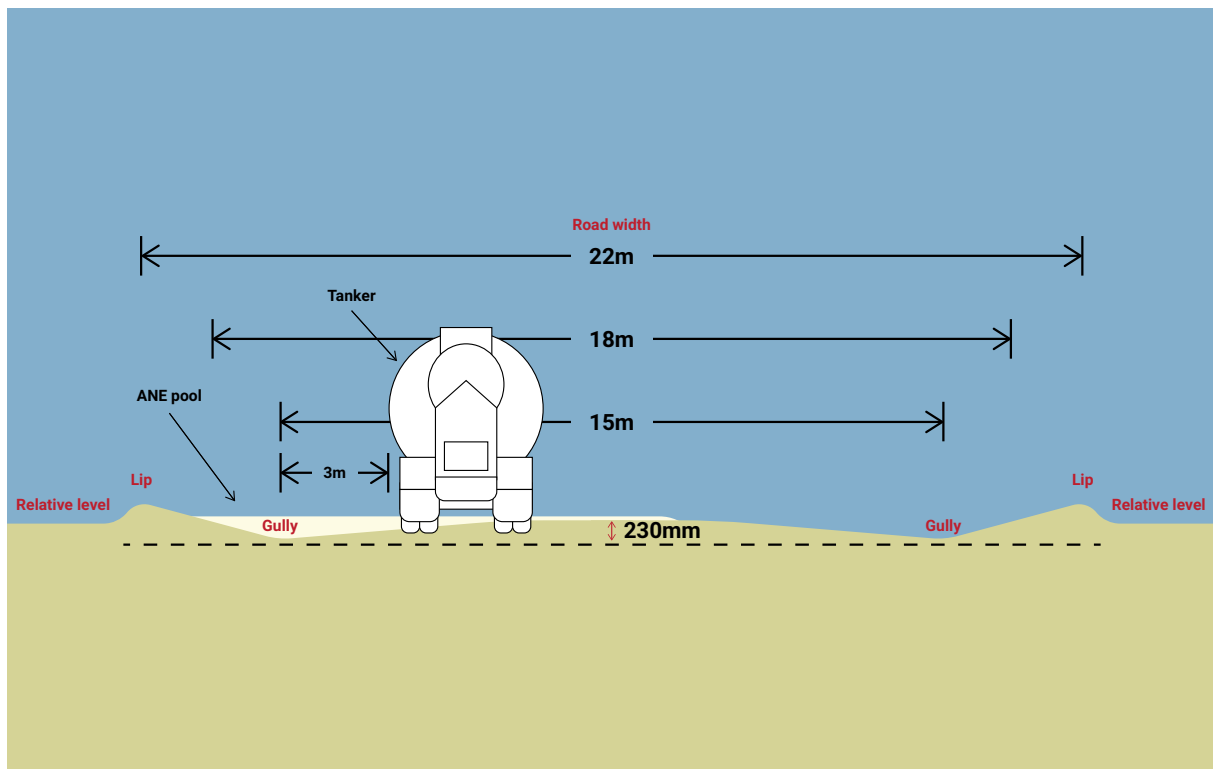
Figure 9.2 Schematic of the road and approximate location of the tanker trailer and dolly. The ANE pooled into a gully on the passenger-side and beneath the tanker trailer after a loss of containment occurred
