Significant Incident Report No. 285

Subject: Near miss when an excavator fell from crane during lifting operation

Date: 03 March 2021

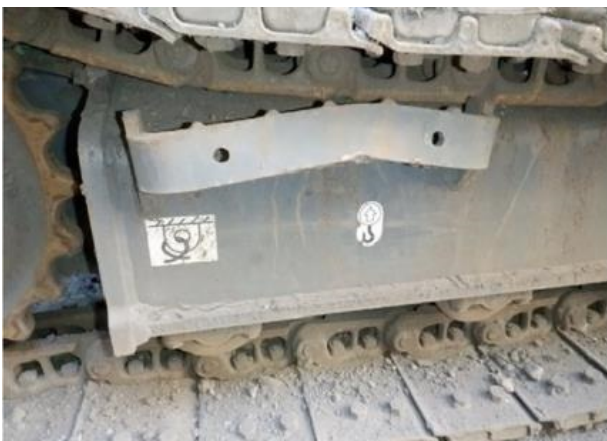
Left: Damaged step used as a lifting point with lifting point signage. Right: Rear track frame with failed step weld.

The weld attaching the access step to the rear track frame separated, resulting in a loss of control of the load, and subsequent failure of the chain slings attached to the excavator.

- The rigging arrangement was not configured as per the original equipment manufacturer's (OEM) recommendations, which required the use of a spreader beam and lifting slings installed below the track frame between the lower track rollers.
- The task job hazard analysis (JHA), detailed job plan and lift study did not require the workers to refer to the OEM's manual for the correct lifting procedure for the equipment.

- The excavator has signage attached to the track frame below the access steps indicating the location of the lifting point; however, this signage does not clearly identify or display the approved lifting method.
- The rigger who attached the lifting chains to the excavator believed that the signage located near the excavator access steps indicated that the step was the approved lifting point.

- ensure workers involved in lifting operations review and follow the OEM's lifting procedure
- ensure the task-based risk assessment (e.g. SWMS, JSA, JHA, THA or lift study) is reviewed, assessed and approved by the supervisor
- confirm that the persons conducting dogging and rigging operations have the appropriate high risk work licences and have been assessed as competent
- confirm all lifting equipment used for the lift has been inspected and is suitable for the task
- isolate the hazard from the people while conducting lifts (e.g. use exclusion zones).
