Significant Incident Report No. 289

Subject: Damaged excavator recoil spring fragment became a projectile

Date: 11 January 2022

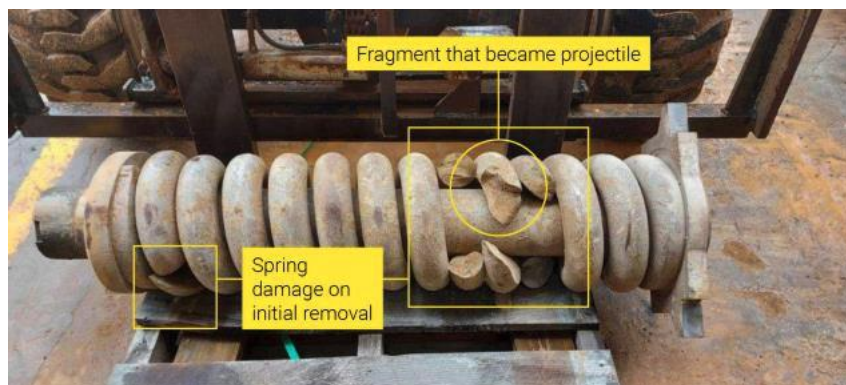
Recoil spring after removal from excavator prior to incident.

- The recoil spring assembly is designed to be installed and removed as a pre-assembled unit with the spring compressed/pre-loaded by approximately 58,000 kilograms of force.
- No information was provided by the original equipment manufacturer (OEM) on the potential hazards associated with performing work on the track recoil assembly with a damaged spring.
- Prior to removal, the recoil spring was inspected via the inspection window on the side track frame, which identified sections of the spring were cracked and missing.
- Although the spring had cracks and segments missing, the assembly remained under compression/load after it had been removed from the excavator, despite the integrity being compromised and susceptible to failure while under load.

- Ensure suitable safe systems of work are in place and followed when installing or removing pre-loaded spring assemblies.
- If spring damage is observed, where practicable, release all stored energy from the spring in a controlled manner prior to removal from the equipment.
- Develop and implement suitable controls to manage the potential stored energy hazard associated with the removal or dismantling of a damaged spring assembly.
- Ensure recoil spring assemblies are inspected and maintained as per OEM recommendations.
- Confirm workers performing maintenance and repair work are adequately instructed, trained and assessed as competent prior to conducting work.
