# Safety and Health Snapshot for the Western Australian minerals sector

## Vehicle and mobile equipment rollovers

Issued June 2022

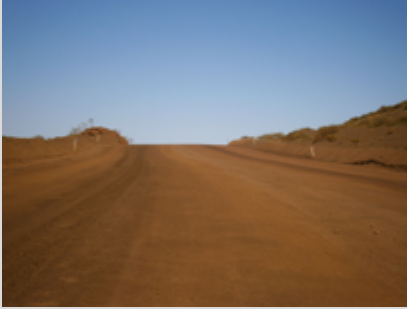
## Spotlight on Mines Safety Significant Incident Report No. 267

### Haul truck operator loses control descending ramp on haul road – fatal accident

15 August 2018

- The truck exceeded the speed at which the electric braking system could stop it.
- The service or mechanical brake was not engaged for an emergency stop.
- The truck was fully loaded descending a long slope.
- Immediately preceding the crest of this long slope there was another crest followed by a short downhill and then an uphill section in the form of a saddleback.

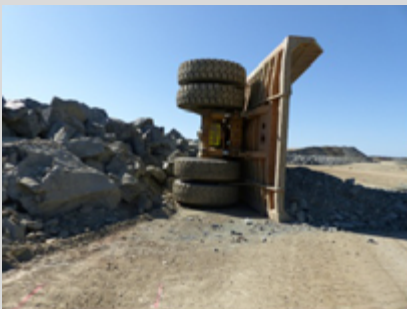
## Spotlight on Mines Safety Significant Incident Report No. 230

### Dump truck roll-over – fatal accident

6 September 2015

- The dump truck mounted the hard rock windrow, changing its centre of gravity and causing it to roll over.
