Significant Incident Report No. 216

Subject: Fire in processing plant laboratory

Date: 18 May 2015

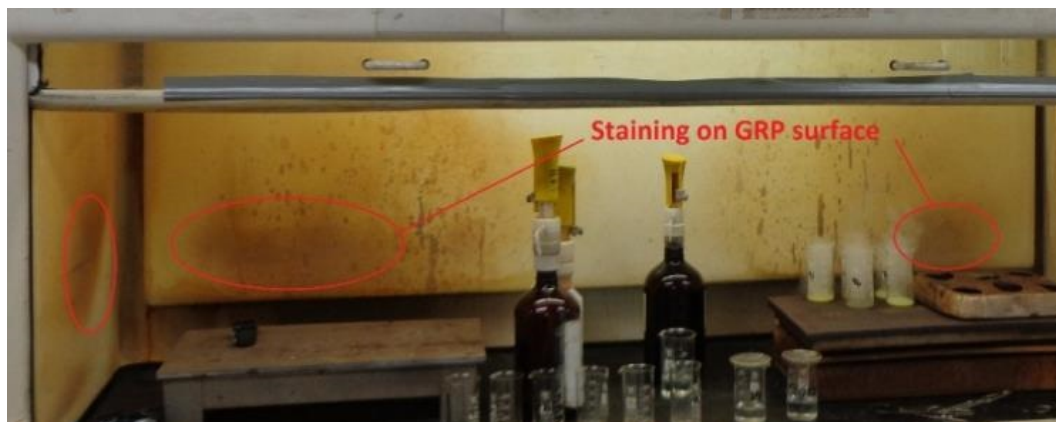
- Continuous use of the fume cupboard did not allow for scheduled maintenance of the chemical resistant surface of the panel.
- Deterioration of the fire-retarding gel coating on the rear wall panel of the fume cupboard exposed the underlying glass reinforced plastic (GRP) panel. This led to resin degradation and subsequent ignition during an acid digestion process. (Figure 1 shows an example of chemical staining and degradation of fire-resistant panels in a fume cupboard).

- Maintenance of the fume cupboard, as recommended by original equipment manufacturer (OEM), was not undertaken.
- Inspections by the certified service provider did not identify the fire hazard of the damaged gel coating on the rear wall panel.
- Risk assessments did not identify fire risks associated with acid digest processes.
- There was no fire collar installed between the exhaust vent and laboratory wall.
- The laboratory building was of a sandwich foam construction, with no fire retardant properties, and no fixed, fire-suppression system in place.

- Developing and implementing a laboratory safety management system based on AS/NZS 2243.8 *Safety in laboratories - Fume Cupboards*.
- Developing and implementing safe systems of work for operating and maintaining equipment, including fume cupboards in laboratories, which refer to, and comply with, OEM recommendations.
- Ensuring service providers engaged to inspect and service fume cupboards are competent.
- Ensuring workers are trained in the safe systems of work.
- Ensuring workers are trained to identify and report hazards, such as equipment degradation, and that reported hazards are adequately addressed and managed.
- Ensuring installation of equipment meets fire regulations.
- Ensuring buildings are fit-for-purpose and meet fire regulations.
