Government of **Western Australia**
Department of **Mines, Industry Regulation and Safety**
Dangerous Goods Safety

Incident investigation report

Ammonium nitrate emulsion tanker trailer explosion

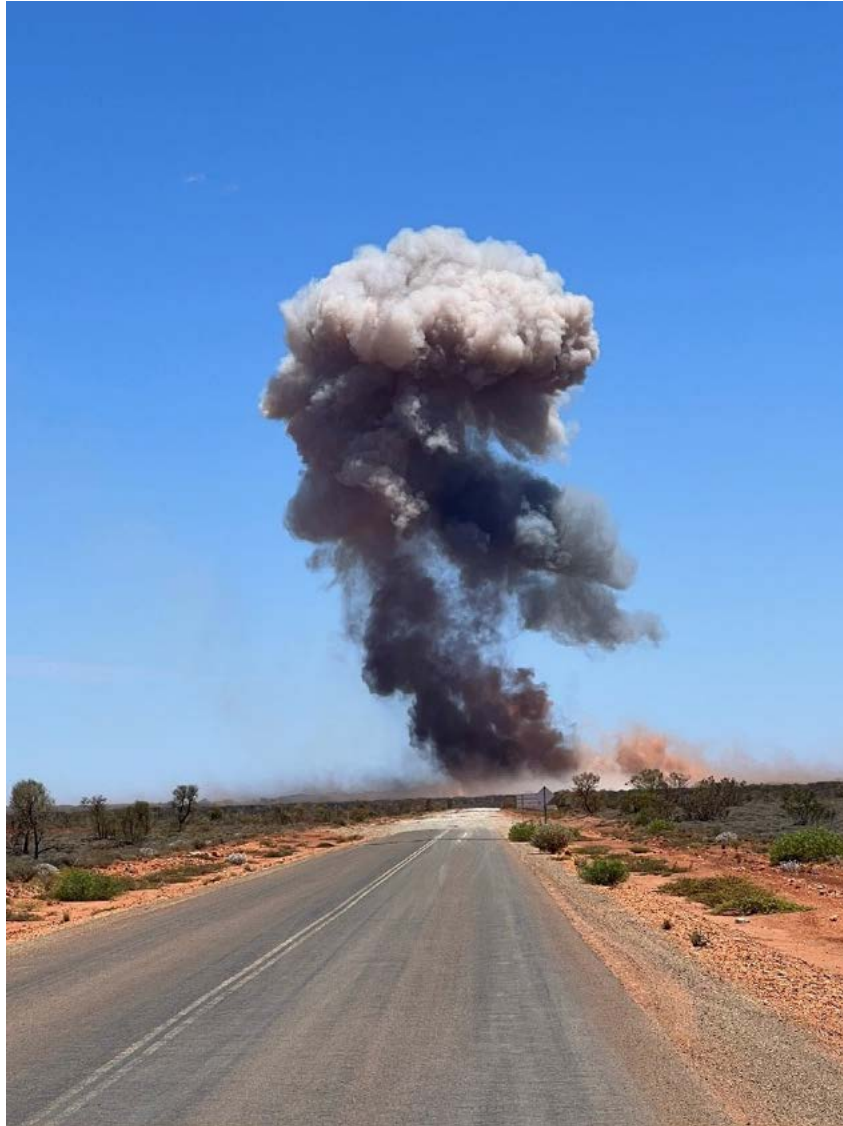
Figure 4.7 Image of explosion cloud captured by the ERT at 3 km from the blast facing a westerly direction (Credit: Gold Fields, Gruyere JV)

Notes: the orange cloud to the right of the cloud is highly likely to be Pindan dust, caused by the explosion. The road in shot is located near the intersection of the Great Central Road and Mount Shenton-Yamarna Road. The Great Central Road is bituminised approaching the mine turnoff on both sides.

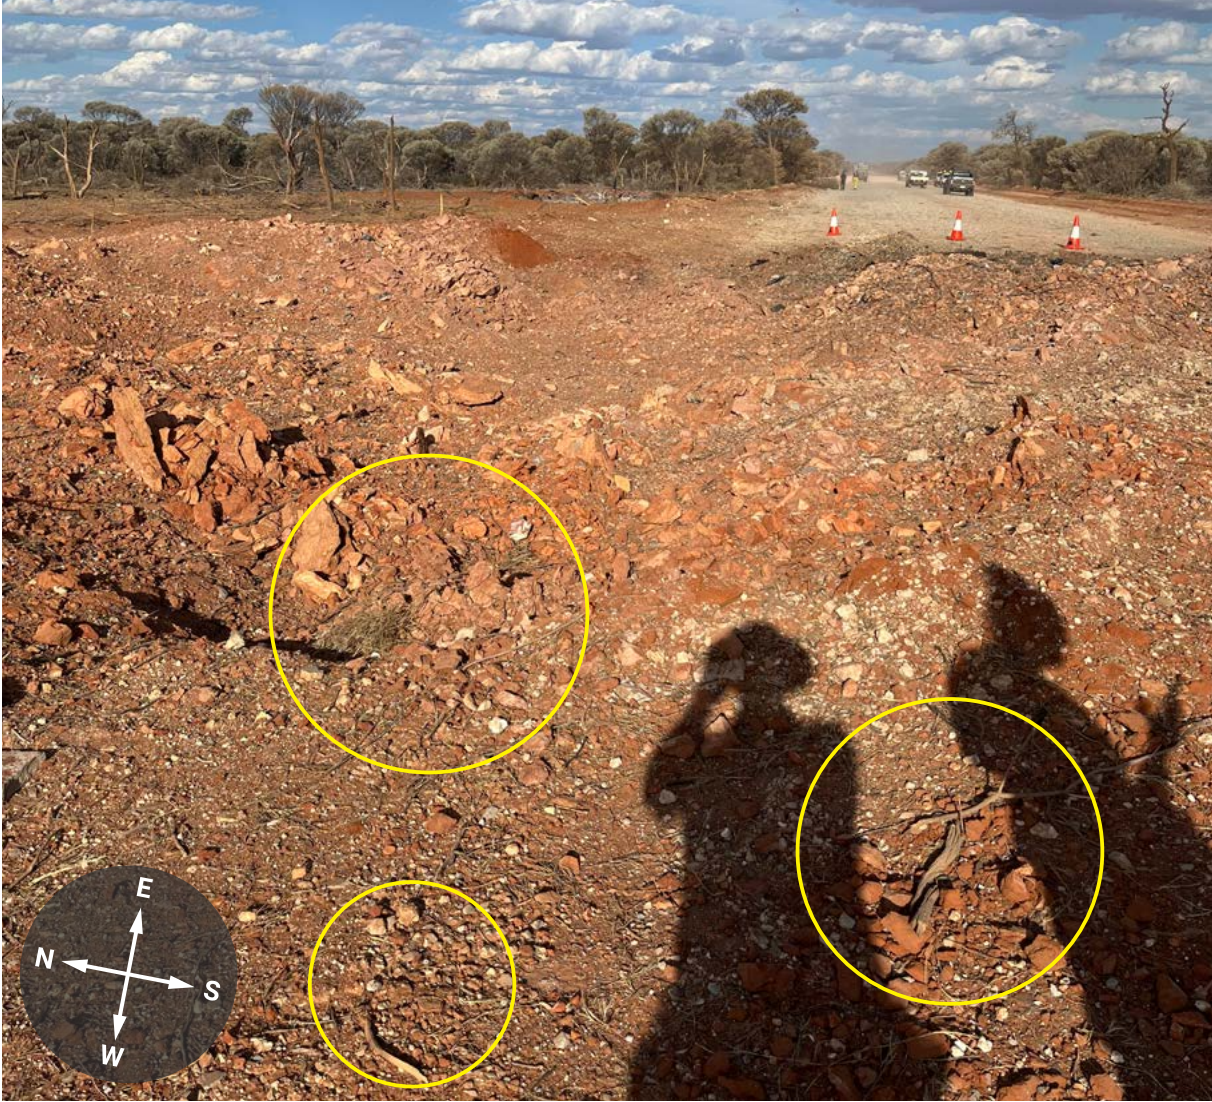
Figure 5.9 Vegetation within the crater following the blast overpressure (Credit: WA Police)

A number of photos were taken by DFES and WA Police prior to the backfilling of the crater and opening of the road (Figures 5.9, 5.10, 5.11 a and b). Some of these images show large lumps of solidified molten aluminium in the crater and small pieces of vegetation. It is likely that the vegetation in the crater was sucked in from the vacuum that followed the blast overpressure.

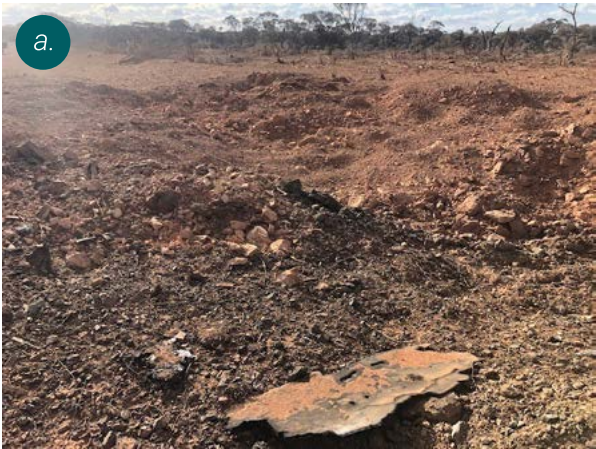
Figure 5.11 a Image of the crater looking north-west (Credit: DFES)

Solidified molten aluminium is indicative that melting of the aluminium tank shell had occurred due to an intense fire prior to the explosion. A large piece can be seen within the crater from the images taken (Figures 5.10, 5.11 a and b). The density of molten aluminium is approximately 2.7 grams per cubic centimetre (g/cc) and would have pooled under the lighter decomposing AN mixture. Some of this aluminium was found within the crater following the explosion.

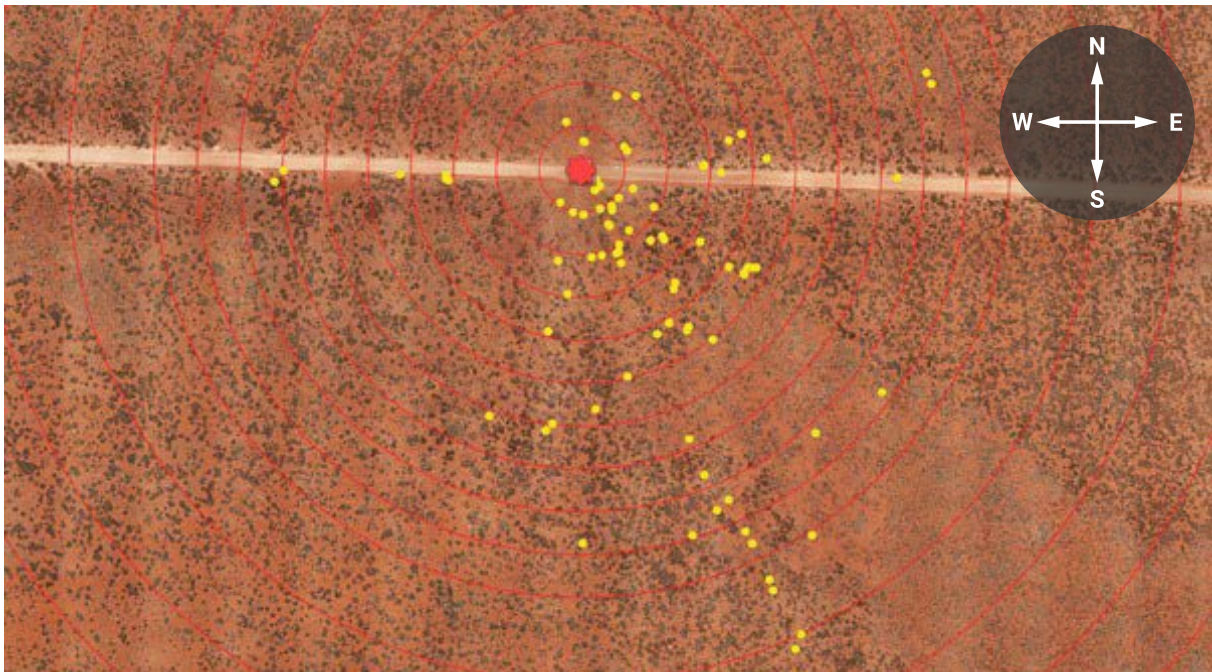
Figure 5.17 Distribution of significant shrapnel and debris (includes aluminium, steel and other debris) located at the incident scene represented in yellow. The red marker indicates epicentre of explosion. The red circles indicate the distance in 50 m intervals to 500m from the epicentre of the explosion, and then at 100 m intervals from then on (Credit: Gold Fields, Gruyere JV; annotated by the Department)

Figure 5.17 demonstrates the general scattering of debris that was distributed across the debris field. The sizes of the shrapnel varied from very small pieces of aluminium metal (less than 10 cm²) to large chunks of steel (weighing upwards of 100 kg).

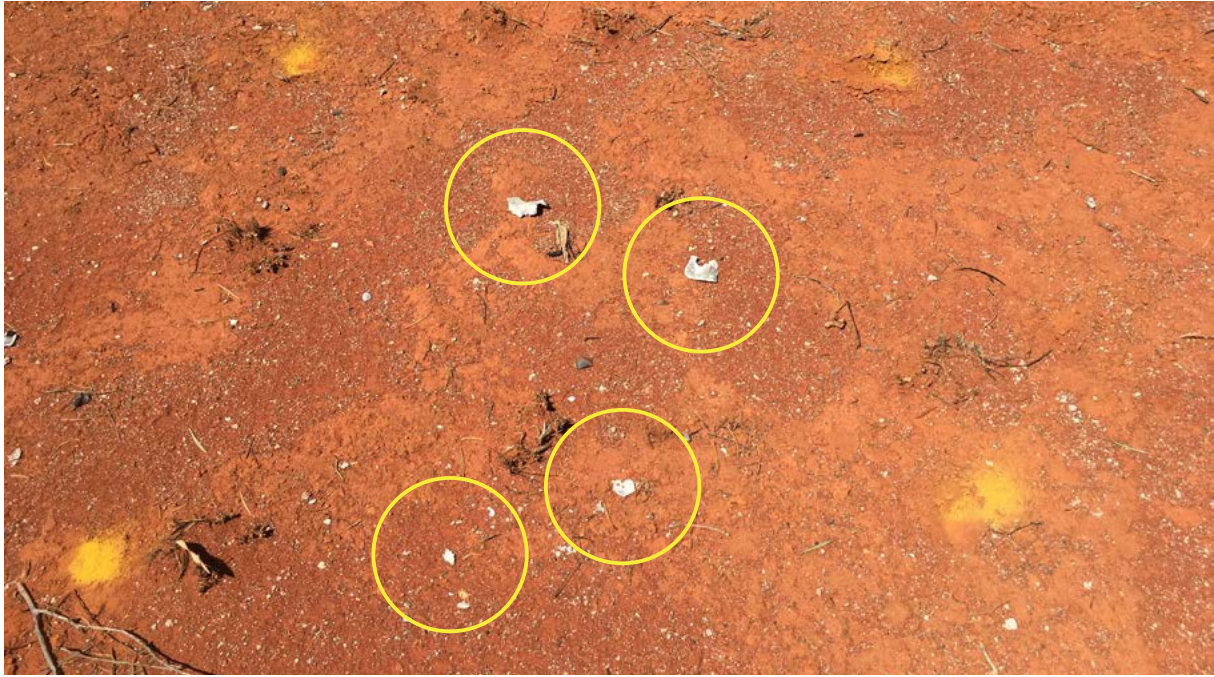
Figure 5.19 Example of 1 m by 1 m survey located at 250 m south of the epicentre. There were other pieces of aluminium (from the tanker shell) less than 10 cm² per m²

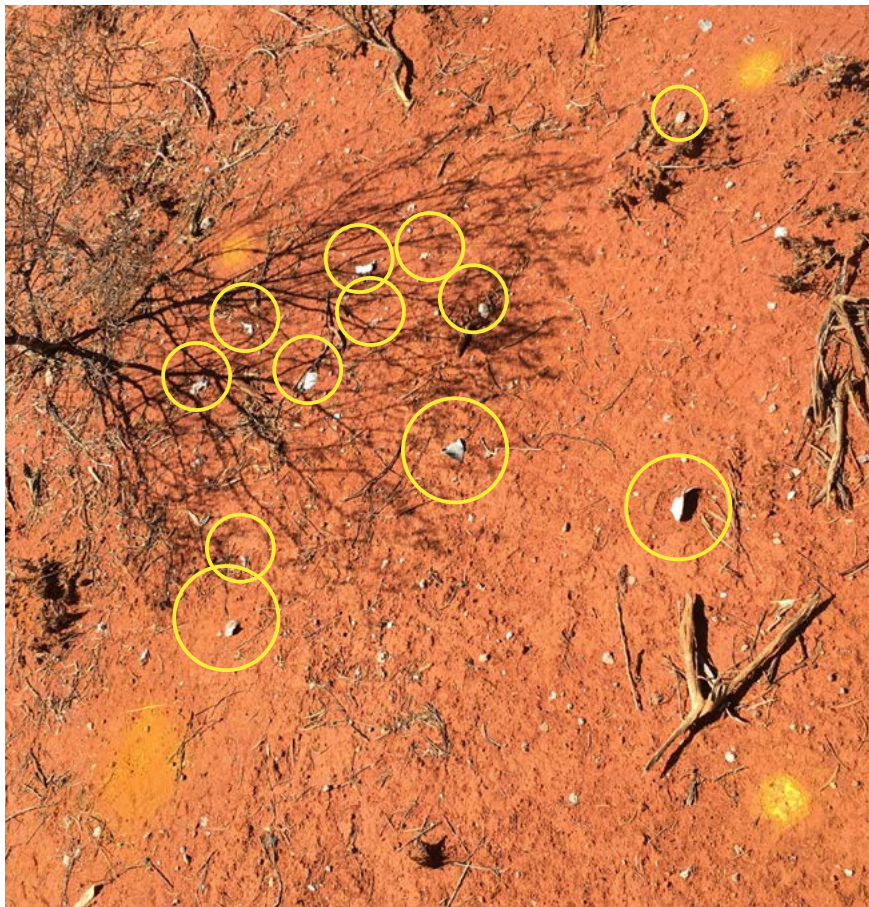
Figure 5.20 Example of 1 m by 1 m survey located at 110 m south of the epicentre. There were twelve pieces of aluminium (from the tanker shell) less than 10 cm² per m²

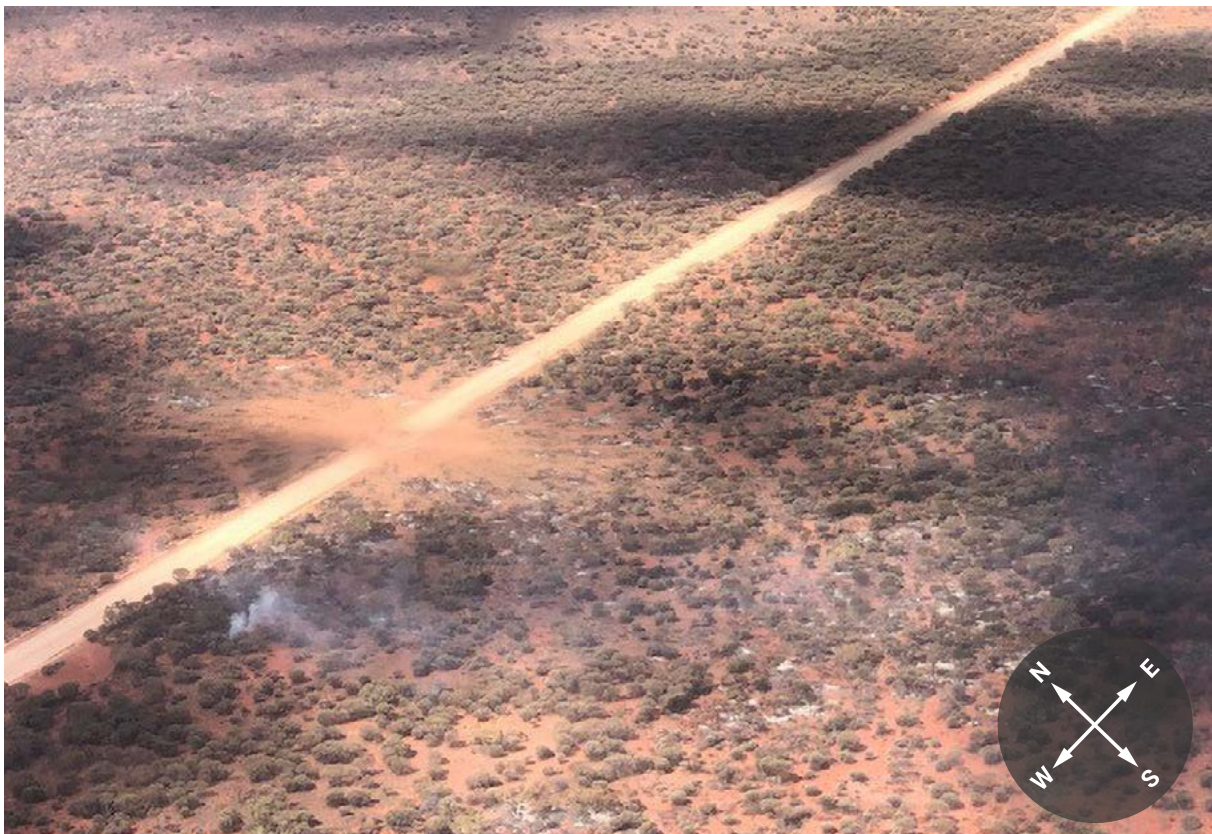
Figure 5.34 View following the explosion

On 26 October 2022 when the Department's investigators, arrived, some ash spots were still smouldering. Later exploration on foot determined that spot fires were found up to approximately 750 m from the crater. The presence of a spot fire provided a good indication for the presence of metal shrapnel.

Note: Spot fires are still burning and most significant distribution of ash is to the south-east of where the vehicle was positioned (Credit: DFES).

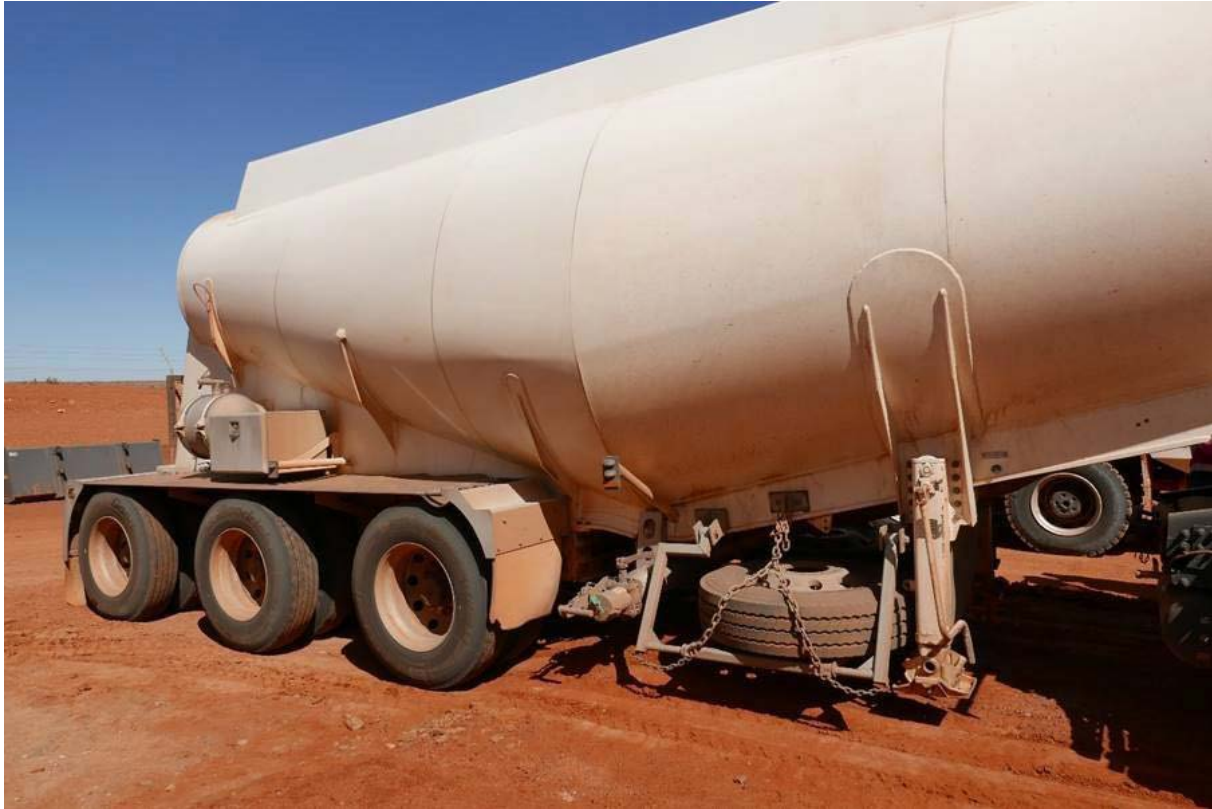
Figure 9.3 Image of lead tanker trailer that arrived at Gruyere mine

Another possible cause of the fire spreading from the rear to the front axle group of tyres is that the centrally located spare tyres acted as a fire bridge to set the front axle group of tyres alight (Figures 9.3 and 6.2).

The distance between the spare tyre and the nearest rear tri-axle is approximately one third of the distance between the two tri-axle groups, meaning it is more likely that the flames could have spread via the spare tyres rather than from tri-axle to tri-axle.

Note: The proximity of the spare tyre to the rear tyres, as well as proximity to the ground.

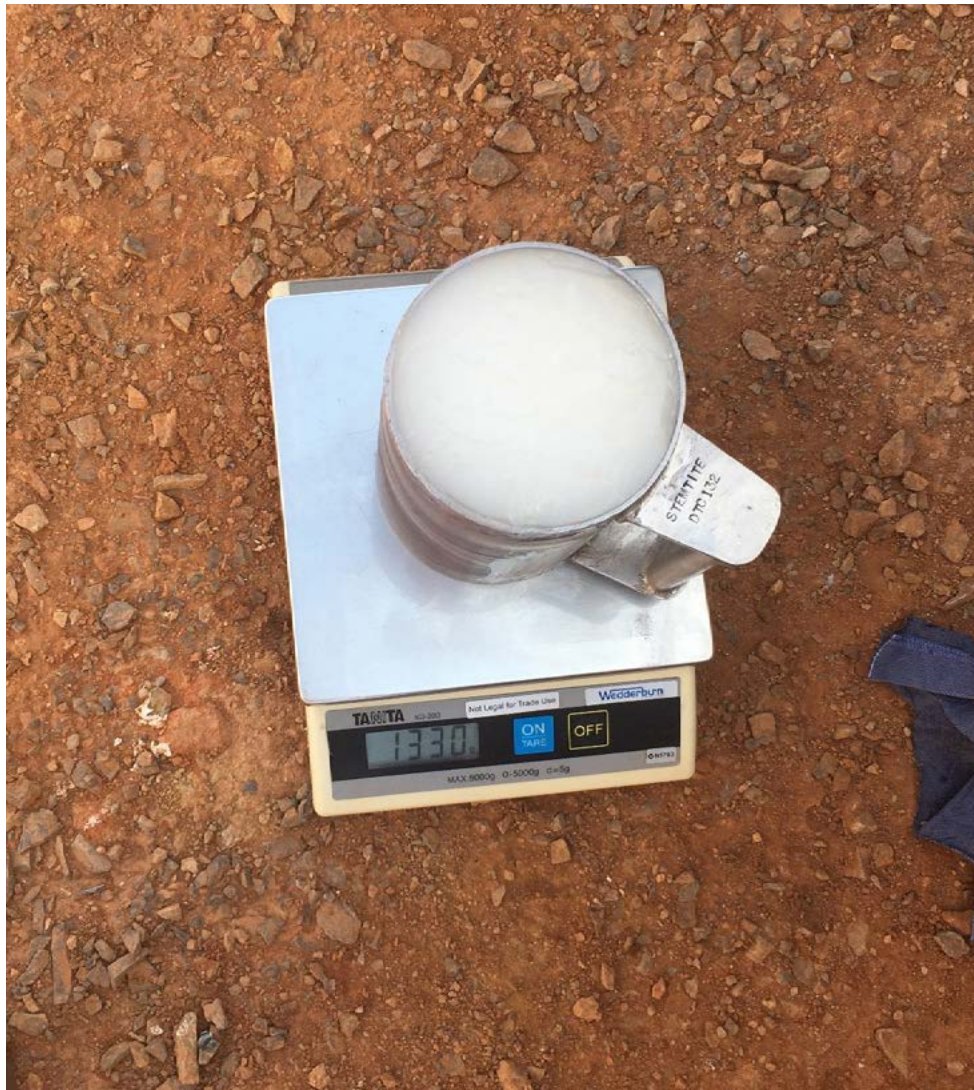
Analysis results of the two samples (from the lead tanker and the sample retained by the manufacturer) were consistent and within the manufacturer's tolerances for this formulation, chemical analysis, physical property tests such as viscosity, density and droplet size.

Figure A4.1 Density measurement of ANE from the tanker trailer that arrived at Gruyere mine site
