## Significant incident summary No. 01/25

### Regeneration gas heater rupture

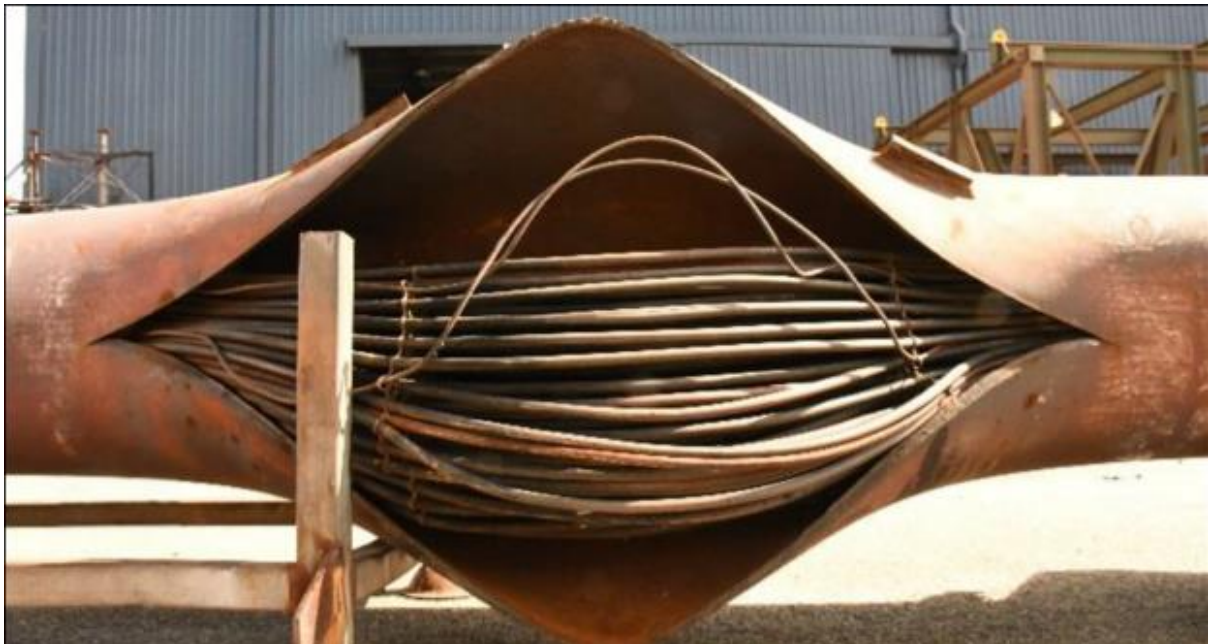
An electrical heating element bundle overheated the vessel to the point of ductile failure, resulting in catastrophic failure of the regeneration heater vessel and a localised flash fire.

***Regeneration gas heater showing area of ductile failure, vessel and heating bundle deformation.***

- Process control:
  - no direct vessel temperature monitoring in control room since the temperature indicator was a digital meter adjacent to vessel
  - absent electrical heating interlock
  - inadequate risk assessment including gas regeneration hazard and operability (HAZOP) analysis and 'no flow' scenario.
- Equipment integrity:
  - faulty vessel thermocouple
  - failure of gas compressor triggered operational change.
- Management of change:
  - no checklist for operating change
  - inadequate work control in manual mode.
- Metallurgical examination:
  - failure of vessel in top section of pipe resulted from excessive heat
  - mechanism of failure had high temperature creep within a relatively short period of time.

- Conduct further HAZOP analysis on regeneration and dehydration circuits.
- Apply 'change control' procedure to process plant changes.
- Ensure control system has two independent temperature controls for regeneration heating circuit.
- Upgrade maintenance system to better capture equipment defects and trigger inspections or repairs.
- Organisational structure change to increase process safety leadership and operational overview.
